14[™] & Agnes Urban Renewal Plan Exhibit F Blight Study

The LCRA staff conducted a site inspection of the project area on October 12, 2019.

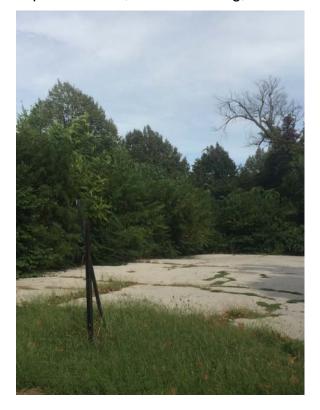
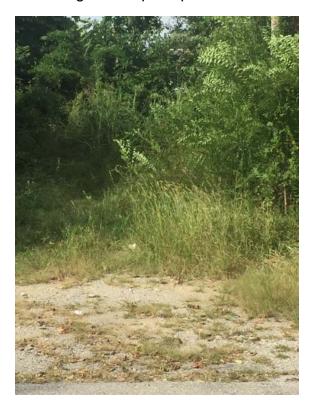
The existing asphalt surface parking lots at 1301 Agnes Avenue and 3020 E. 14th Street have no landscaping islands or borders, has no interior curb-and-gutters or stormwater drainage and, therefore, does not comply with the City's Chap. 52 requirements for off-street parking. The photographs below show the failure of the asphalt surface, uneven settling, and weed growth through the asphalt pavement.

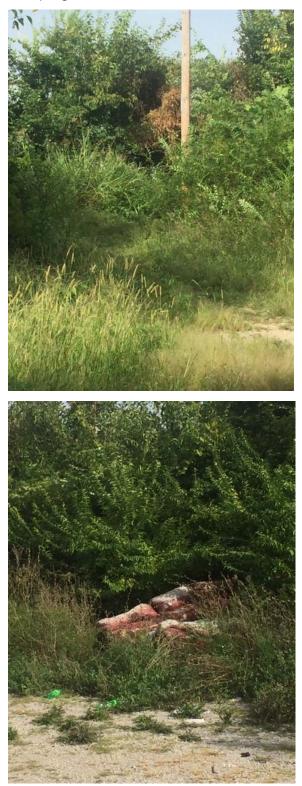
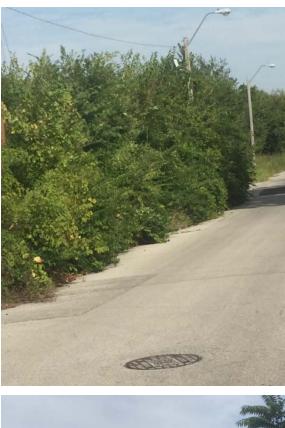
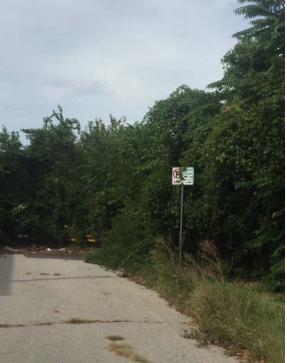
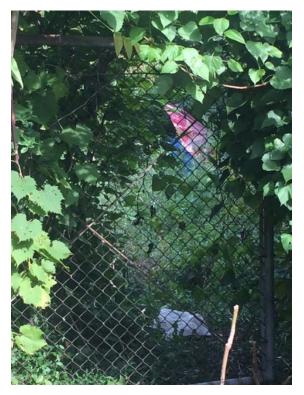
The photographs below shows the complete lack of interior landscaping and stormwater drainage within the off-street parking area, overgrown brush and weeds, and illegal dumping.

Depicted above are the heavy overgrowth along and through the perimeter fencing, as well as evidence of illegal camping.

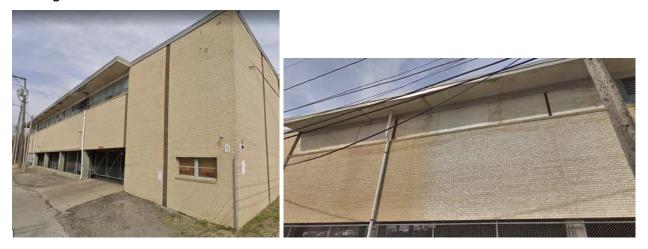
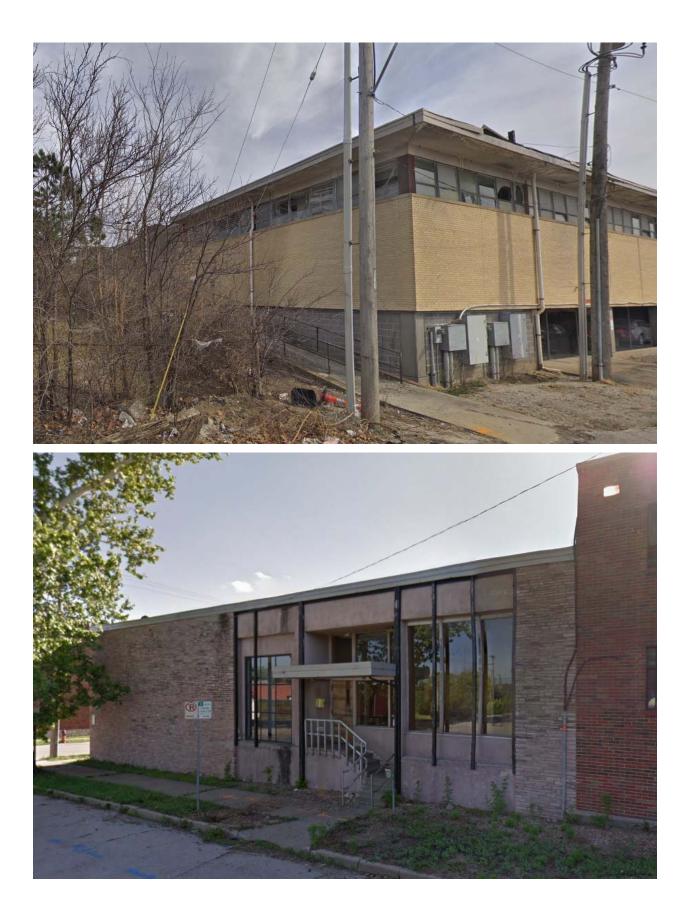
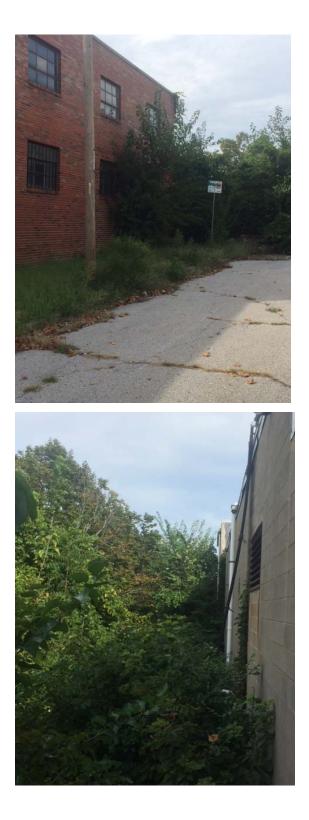
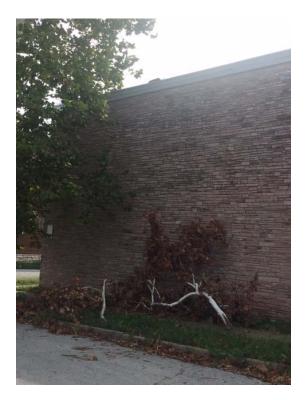
The exterior of the existing building is experiencing a variety of structural issues, deferred maintenance, and unsafe conditions. The photographs below depict failing finishes, damaged exterior walls, soffits, and eaves, deferred maintenance, and debris and trash scattered near and in entrances. The roof has extensive deterioration and damage.

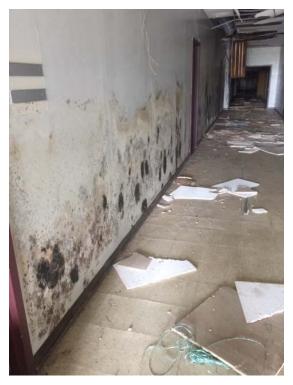
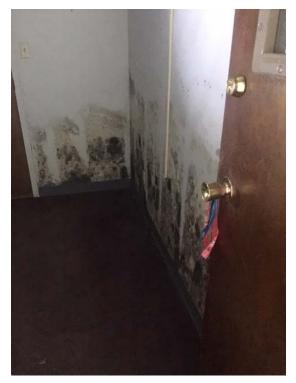
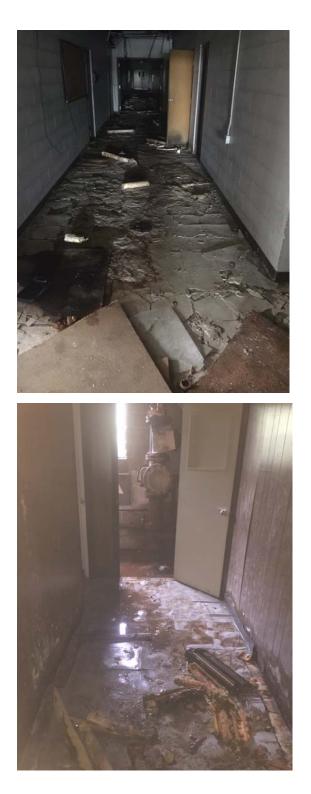
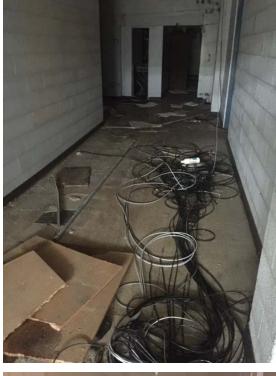
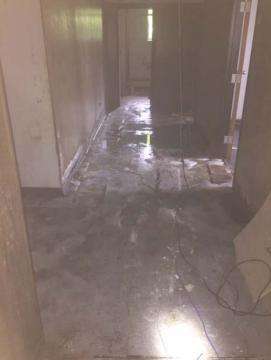
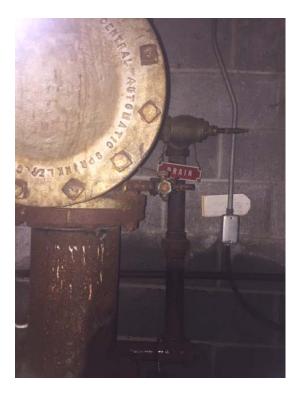
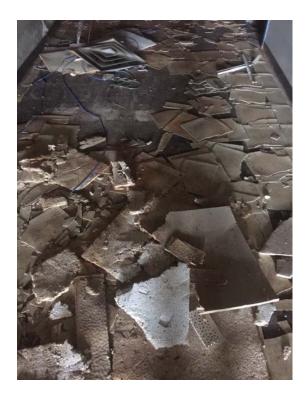
The interior of the building is experiencing a variety of structural issues, deferred maintenance, and insanitary and unsafe conditions. There was standing and dripping water throughout the interior. The photographs below depict extensive water damage to

ceilings, walls, and floors due to the extensive roof damage, and damaged heating, venting, and air-conditioning systems, damaged plumbing and electrical systems. There was trash and litter throughout the interior. The interior wall and floor surfaces were failing due to the water damage. There was mold visible on numerous surfaces, posing an immediate health hazard.
