Re: 3400-3408 Campbell Street URA

## PROPERTY CONDITION REPORT

CLIENT:	Jesse Peoples
INSPECTION ADDRESS:	3400 Campbell St. Kansas City MO 64109
AGENT:	None
DATE:	4/25/2017
INSPECTOR:	Steve Rodriguez
REPORT #:	20170425-3400-Campbell-St

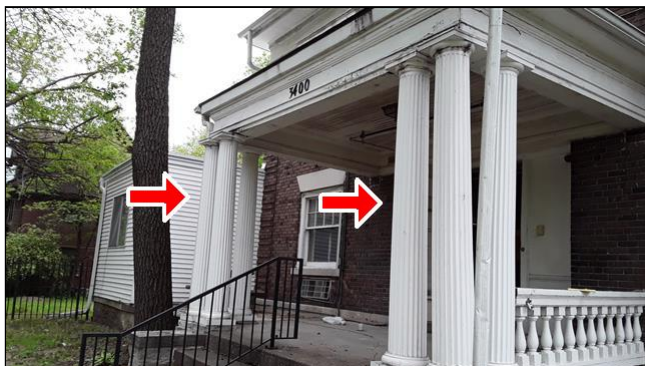
(1) Loose support columns at front porch. Recommend properly securing to maintain proper roof support. No associated structural damages visible during time of inspection.

1.3 Item 1(Picture) - Loose columns at front porch

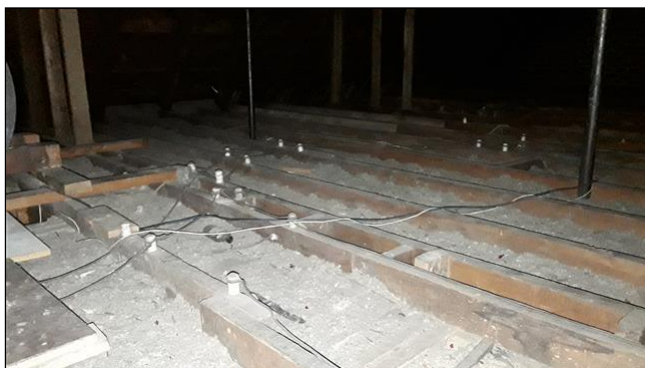
(2) Knob-and-tube wiring system installed within home. This is original to the home and unsafe since today's attics are insulated. Recommend contracting electrician to thoroughly evaluate and replace all areas to maintain safe and reliable electrical service throughout home. No underlying electrical damages visible during time of inspection.

4.5 Item 1(Picture) - Knob-n-tube wiring in attic

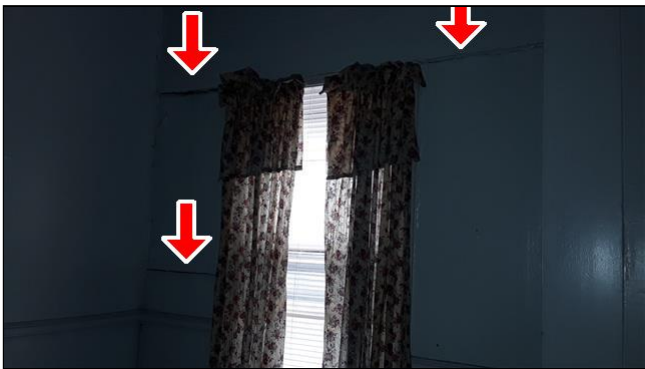
**Specialist Item.**  
Moisture damages visible on South and West walls of home, but no moisture detected during time of inspection. This appears to be caused from previous leakage at roof above stain. Recommend hiring professional roofing contractor to investigate and repair to avoid continued future damages. Unable to determine extent of underlying damages during time of inspection.

5.1.C Item 3(Picture) - Moisture damages on West side of main floor

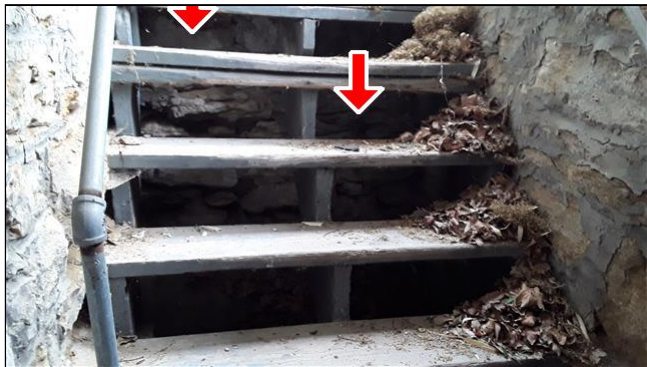
Deteriorated mortar visible at stone retaining wall on West side of home. This condition is a part of normal maintenance in older homes. This is not structurally significant. Recommend properly repointing to avoid further deterioration and underlying damages. No structural damages visible during time of inspection.

2.0 Item 1(Picture) - Deteriorated mortar at basement walkout

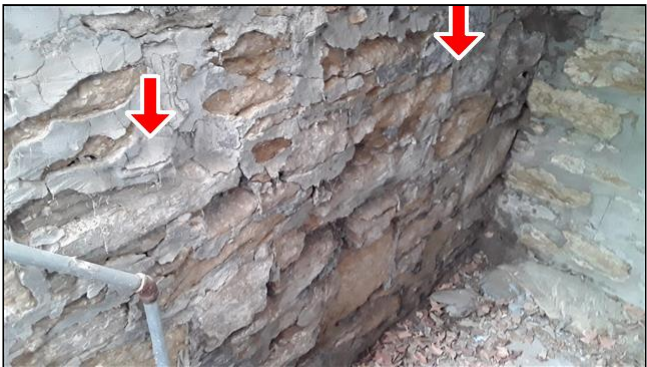
2.0 Item 2(Picture) - Deteriorated mortar at basement walkout retaining wall

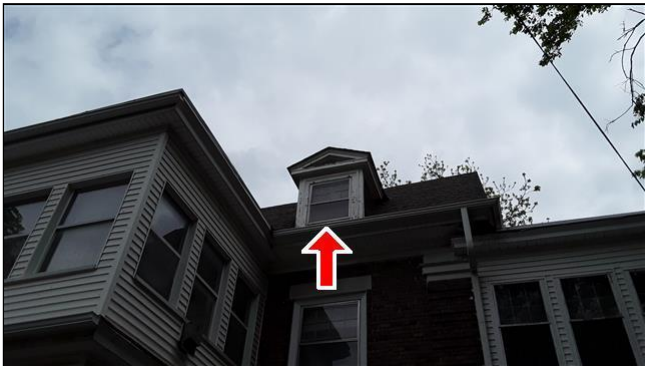
Peeling paint and rot at window frames and sills around home. Recommend properly repairing and repainting to avoid continued damage to underlying framing areas. No significant underlying damages visible during time of inspection.

2.3 Item 1(Picture) - Peeling paint around West side window

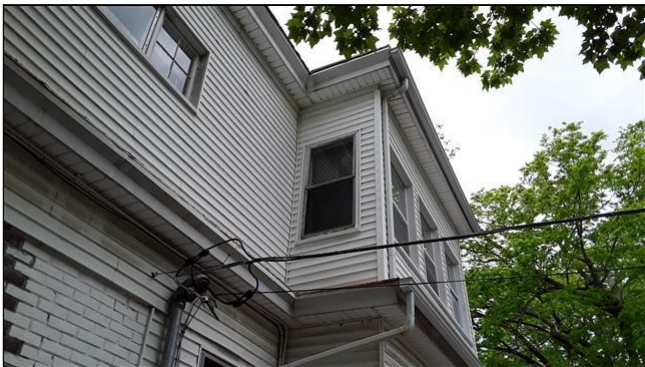
2.3 Item 3(Picture) - Peeling paint and rot on West side

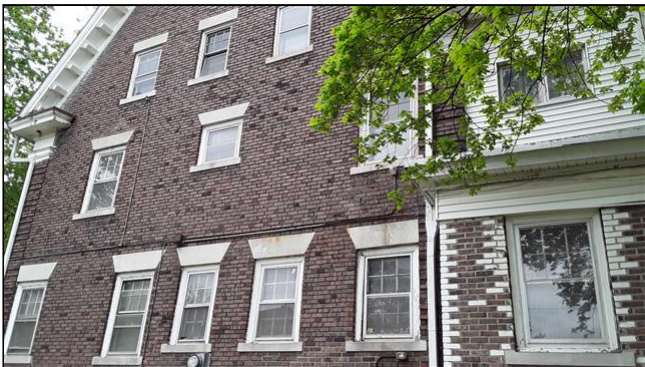
2.3 Item 4(Picture) - Peeling paint on North side

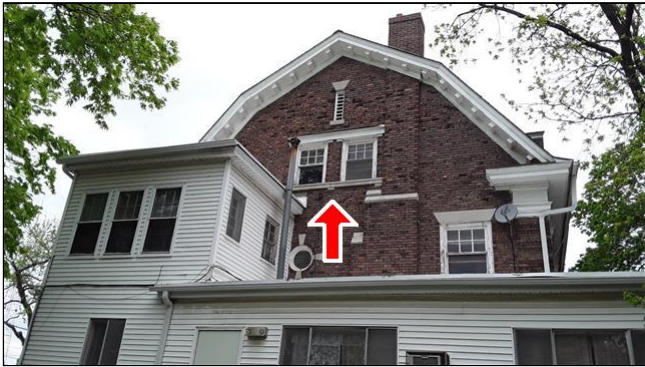
2.3 Item 7(Picture) - Peeling paint and rot on South side

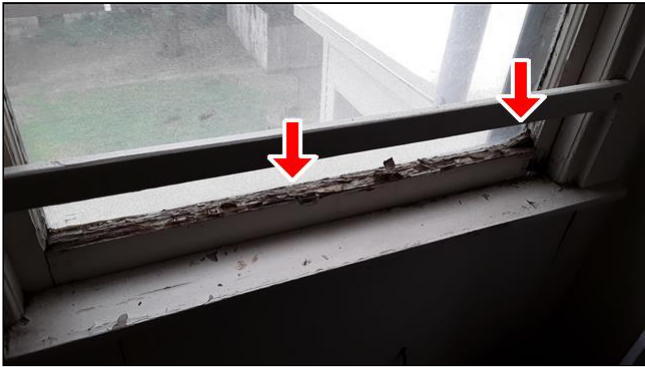
2.3 Item 8(Picture) - Rot at window on South side of home

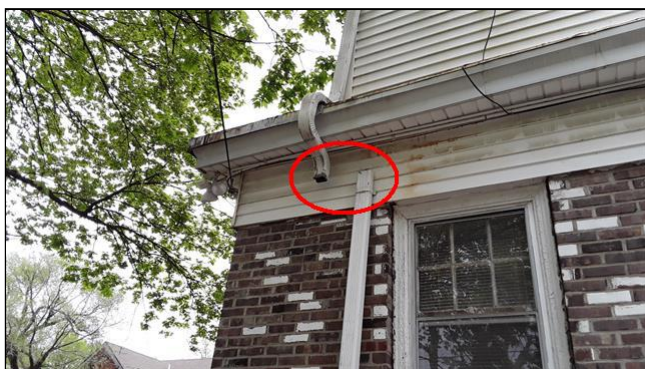
(2) Downspout disconnected at NW corner and North side of home. Recommend reconnecting to facilitate proper drainage away from home and avoid associated moisture damages. None visible during time of inspection.

3.0 Item 2(Picture) - Downspout disconnected at E corner

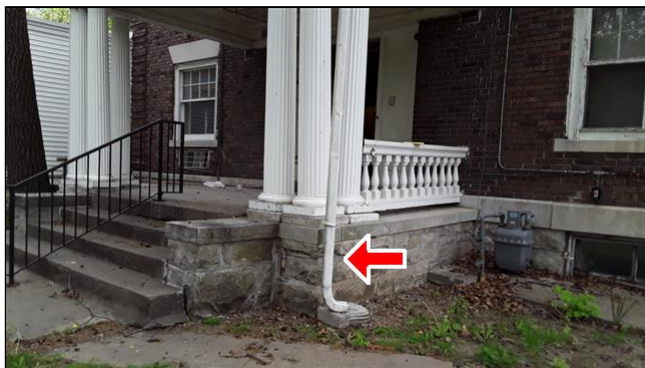
(3) Downspout loose around front porch. Recommend properly securing to maintain reliable water flow away from home and avoid possible moisture penetration and associated damages within basement. None visible during time of inspection.

3.0 Item 4(Picture) - Loose downspout at front porch

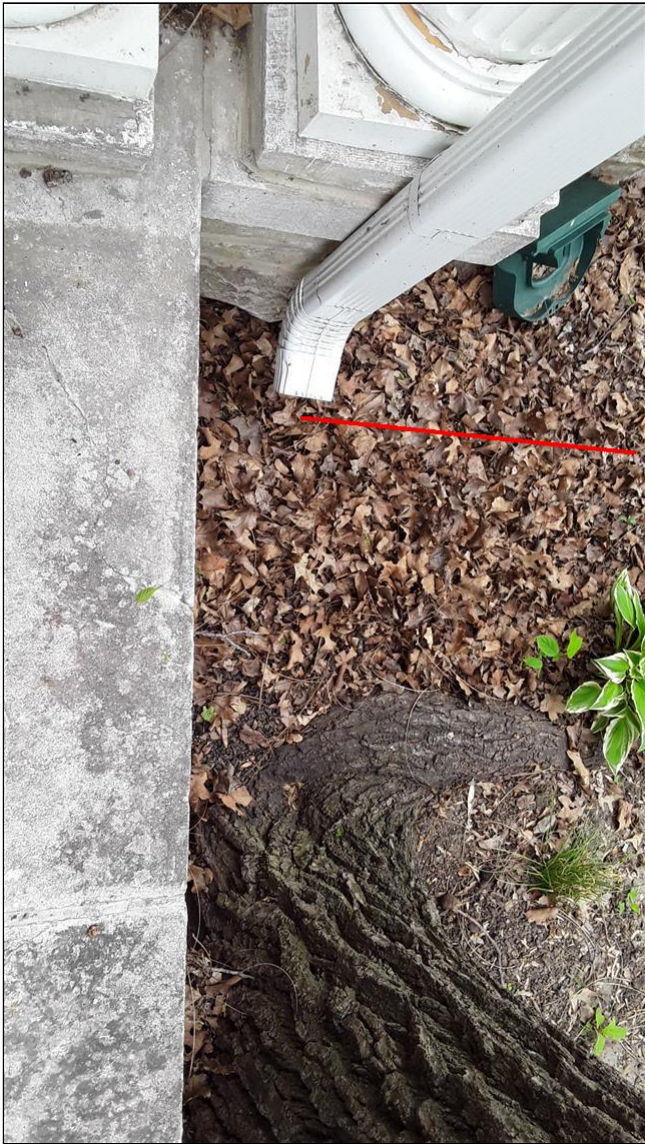
(4) Downspout drains water too close to foundation at front porch. Recommend extending at least 6' away from foundation wall to avoid possibility of moisture penetration and associated damages. None visible during time of inspection.

3.0 Item 5(Picture) - Extend at front porch

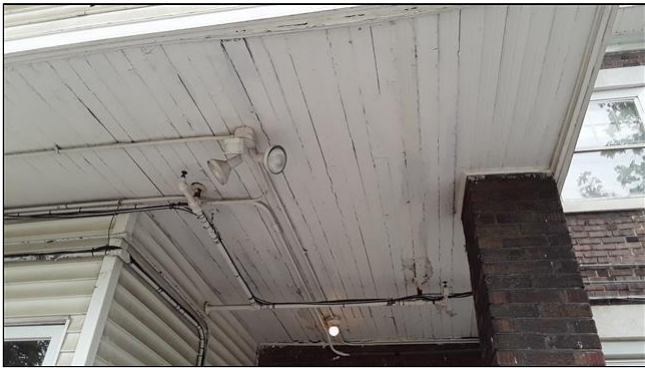
(1) Rot in soffit boards on West side of home. This is normal in older homes. Recommend properly repairing to avoid possible moisture penetration and associated damages to underlying framing areas. None visible during time of inspection.

3.1 Item 1(Picture) - Rot in soffit boards over basement walkout steps

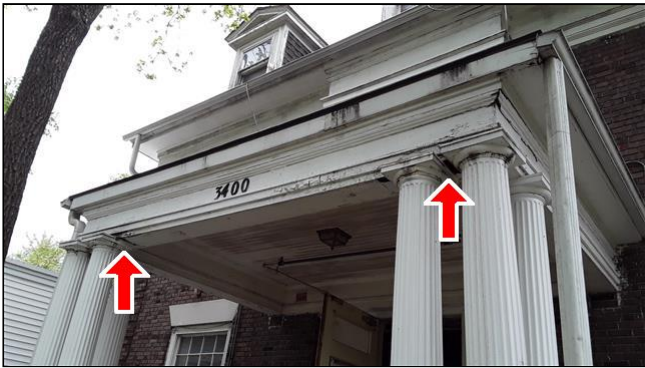
3.1 Item 2(Picture) - Rot at soffits at front porch

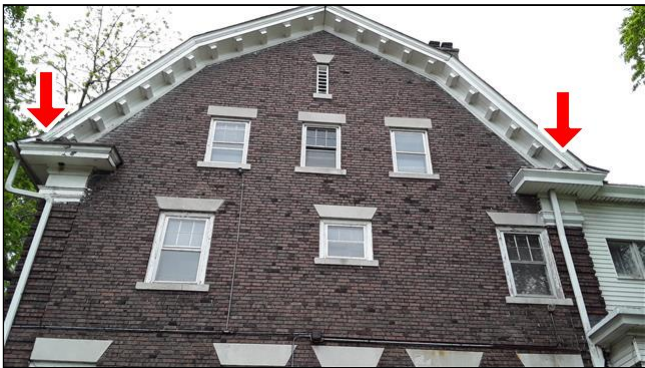
(3) Peeling paint and rot at rake/fascia boards around home. Recommend properly repairing and repainting all damaged areas to extend their useful life. No significant underlying damages visible during time of inspection.

3.1 Item 4(Picture) - Rot at rake boards on North side of home

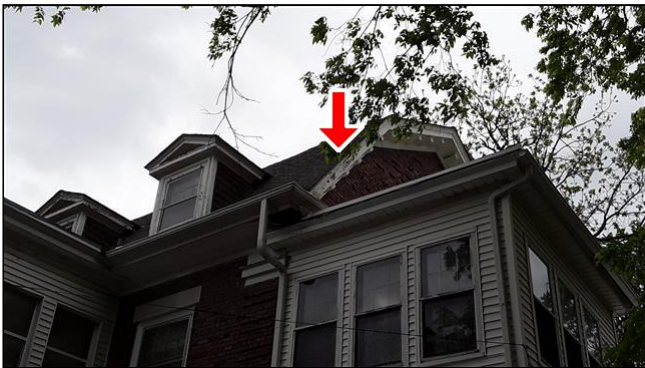
3.1 Item 5(Picture) - Peeling paint on West side

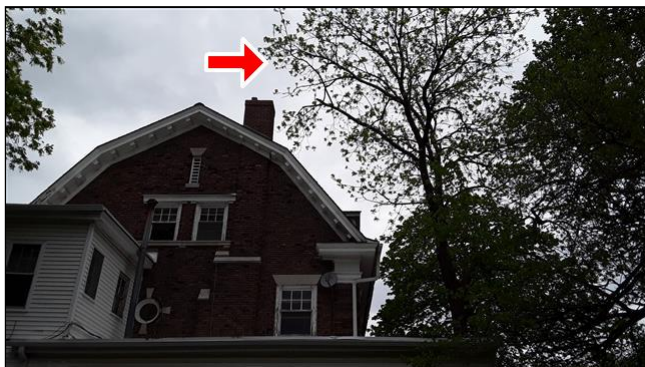
Tree branches overhang onto roof. All tree branches should be kept trimmed back at least 6 to 8 feet from roof and gutters to avoid possible rodent damage and reduce associated debris from clogging gutters. Recommend trimming to avoid associated structural damages. None visible during time of inspection.

3.2 Item 1(Picture) - Tree branches hang over roof

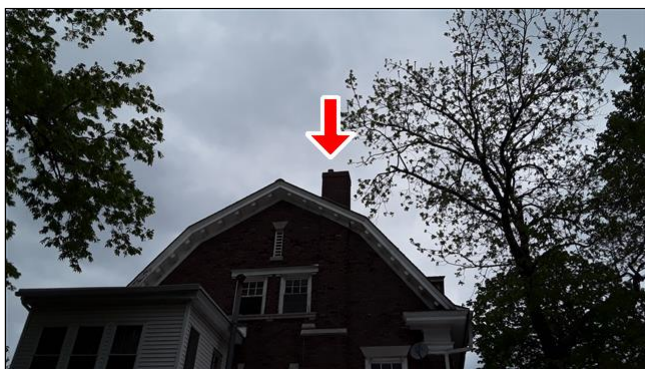
Missing chimney caps. Recommend installing to maintain safe and proper chimney performance. Unable to determine if any underlying damages exist during time of inspection.

3.5 Item 1(Picture) - Missing chimney cap

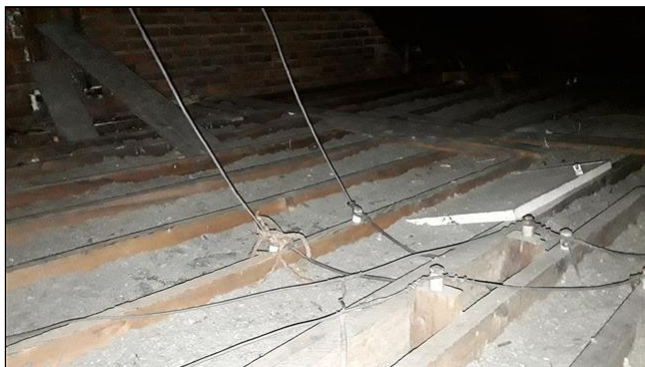
1 inch of blown fiberglass insulation present. U.S. Department of Energy recommends R-38 rating in attic spaces, which equates to 13 inches. Consider providing additional depth to maintain intended energy efficiency to home and reduce associated fuel costs.

4.1 Item 1(Picture) - 1 inch of blown fiberglass insulation in attic

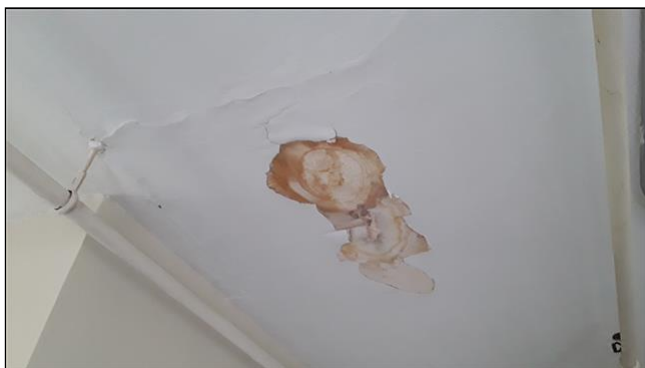
Old moisture stains and damage visible at ceiling at NE corner of top floor, but no moisture detected during time of inspection. This appears to be caused from previous leakage at roof above stain. Recommend properly sealing and painting to avoid future moisture damage. No underlying moisture damages visible during time of inspection.

5.2.A Item 1(Picture) - Old moisture stains and damage at NE corner of top floor

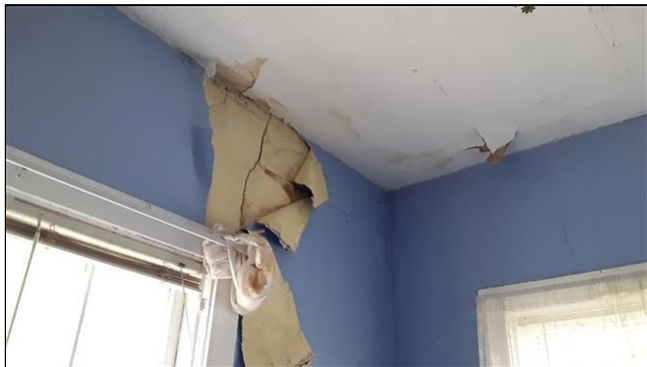
Old moisture stains and damage visible at ceiling on North side of home, but no moisture detected during time of inspection. This appears to be caused from previous leakage at roof above stain. Recommend properly sealing and painting to avoid future moisture damage. Unable to determine extent of any underlying moisture damages during time of inspection.

5.2.B Item 1(Picture) - Moisture stains and damage at NW corner of second floor

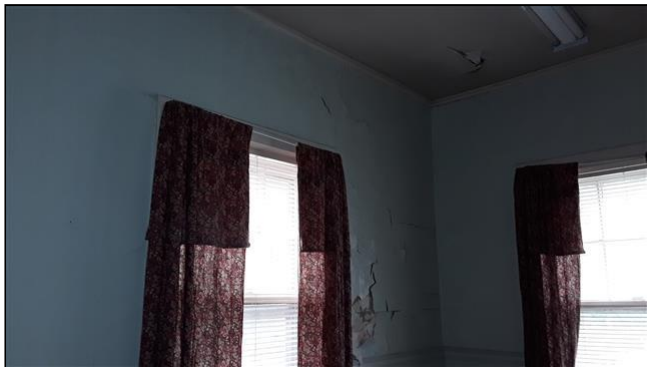
5.2.B Item 2(Picture) - Moisture damage continues onto main floor

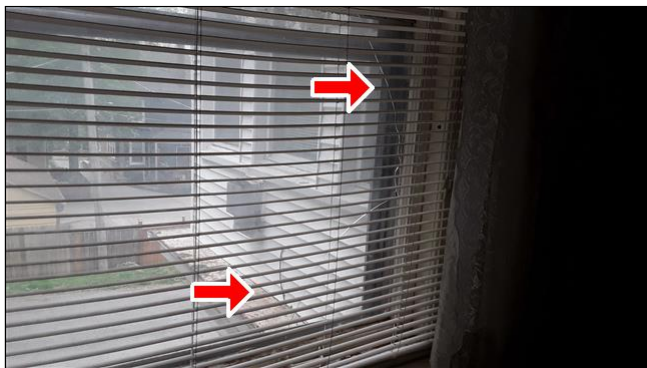
West window has cracked pane. Recommend properly replacing to restore designed energy efficiency to space.

5.3.B Item 1(Picture) - Cracked pane on West side of second floor

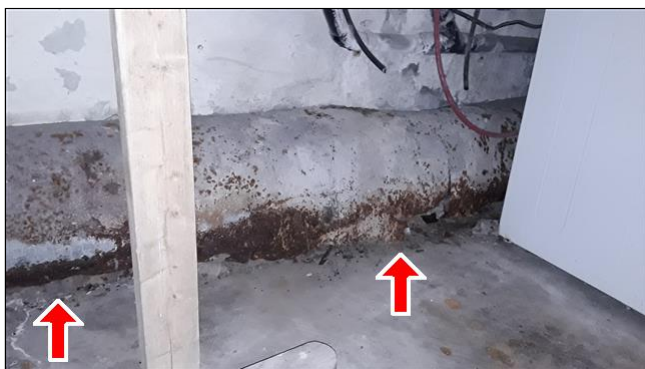
Make-up air vent is corroded within laundry room. This is a possible fire hazard since lint is flammable. Recommend repairing to restore safe and efficient performance.

11.8 Item 1(Picture) - Make-up vent is corroded in laundry area

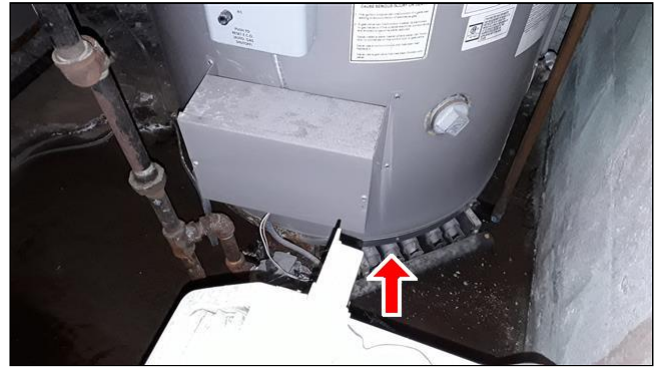
12.5 Item 2(Picture) - Corrosion on bottom of second water heater

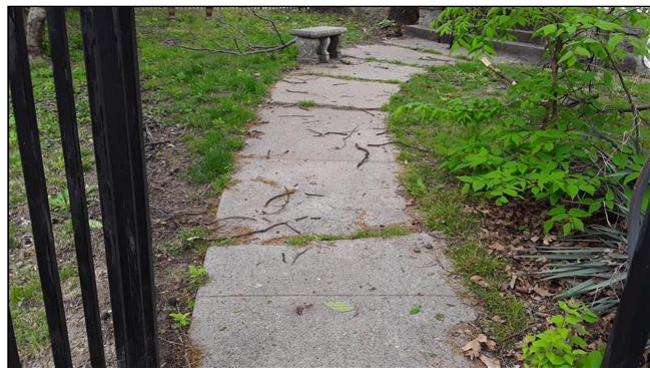
Walkway has moved and cracked to a point where it has created a tripping hazard on East side. Recommend properly repairing to avoid associated personal injuries.

1.2 Item 1(Picture) - Settlement cracking at front walkway

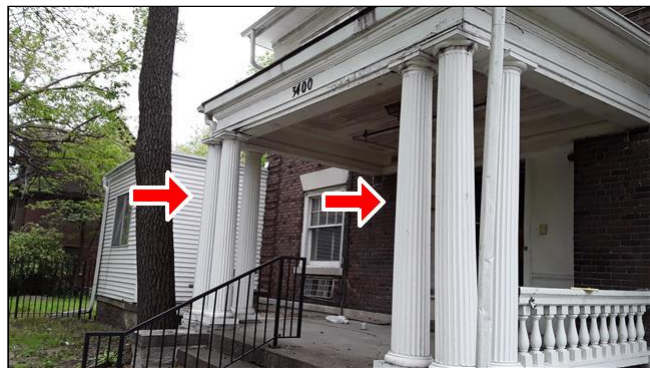
(1) Loose support columns at front porch. Recommend properly securing to maintain proper roof support. No associated structural damages visible during time of inspection.

1.3 Item 1(Picture) - Loose columns at front porch

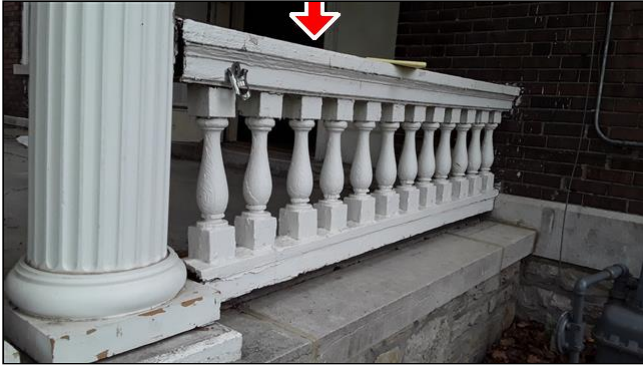
(2) Loose banister at front porch. Recommend properly securing to maintain proper stability during use.

1.3 Item 2(Picture) - Loose banister at front porch

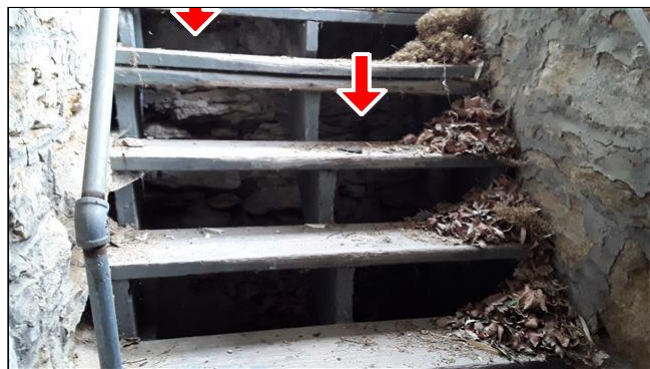
Deteriorated mortar visible at stone retaining wall on West side of home. This condition is a part of normal maintenance in older homes. This is not structurally significant. Recommend properly repointing to avoid further deterioration and underlying damages. No structural damages visible during time of inspection.

2.0 Item 1(Picture) - Deteriorated mortar at basement walkout

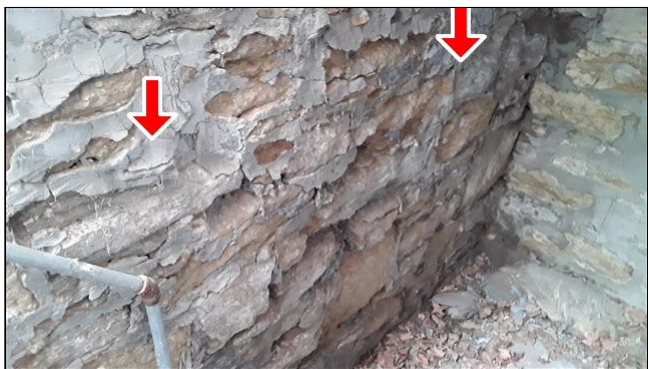
2.0 Item 2(Picture) - Deteriorated mortar at basement walkout retaining wall

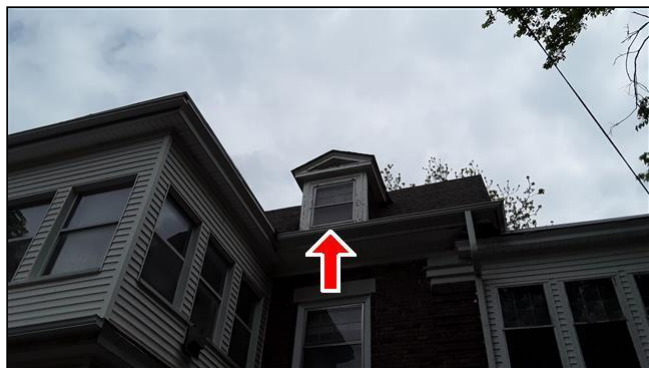
Peeling paint and rot at window frames and sills around home. Recommend properly repairing and repainting to avoid continued damage to underlying framing areas. No significant underlying damages visible during time of inspection.

2.3 Item 1(Picture) - Peeling paint around West side window

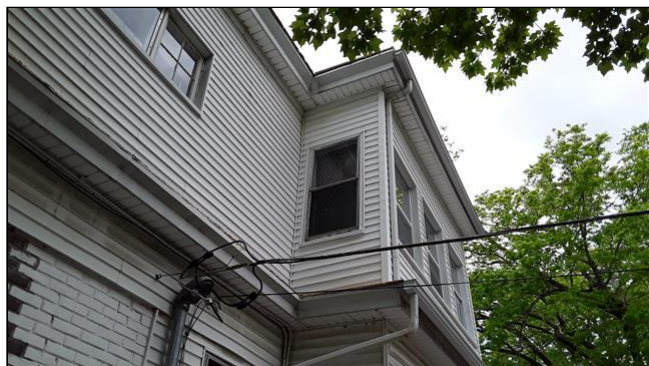
2.3 Item 3(Picture) - Peeling paint and rot on West side

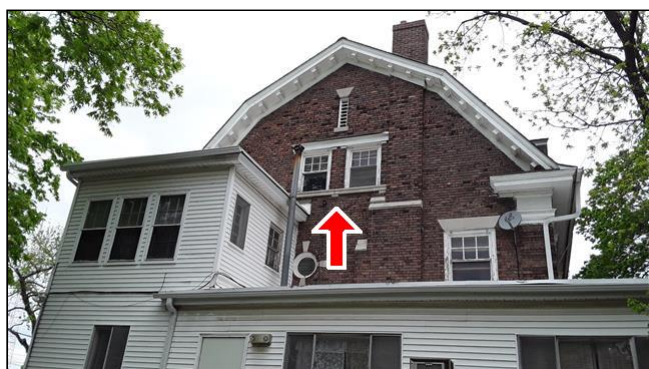
2.3 Item 7(Picture) - Peeling paint and rot on South side

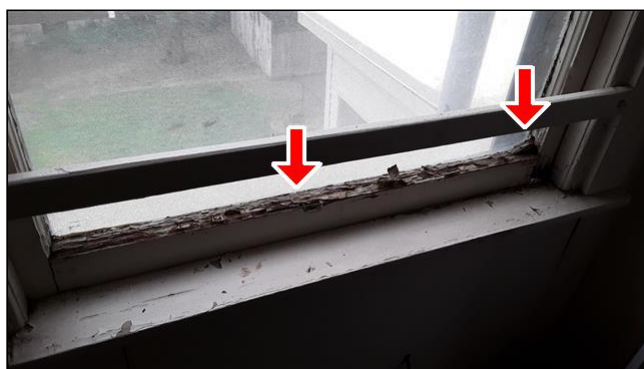
2.3 Item 8(Picture) - Rot at window on South side of home

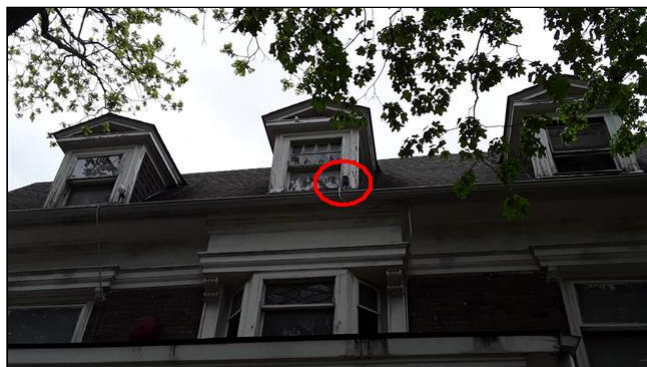
Broken outlet cover above front porch. Recommend replacing to provide necessary weather protection to internal components and avoid associated electrical safety hazards.

2.6 Item 1(Picture) - Broken outlet cover on East side

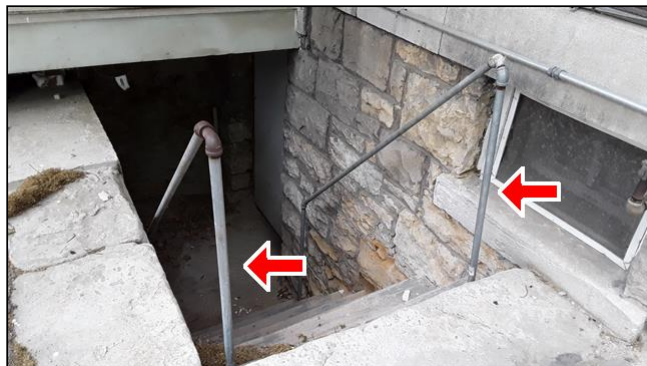
Handrails are loose at basement walkout steps. Recommend properly securing to maintain proper stability during use.

2.7 Item 1(Picture) - Loose handrails at basement walkout steps

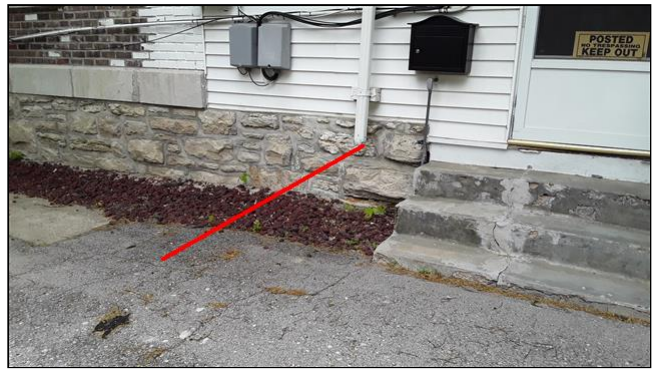
(1) Downspout missing elbow on West side of home. Recommend installing and extending at least 6' to facilitate proper drainage away from foundation and avoid associated moisture damages. None visible during time of inspection.

3.0 Item 1(Picture) - Missing elbow on West side

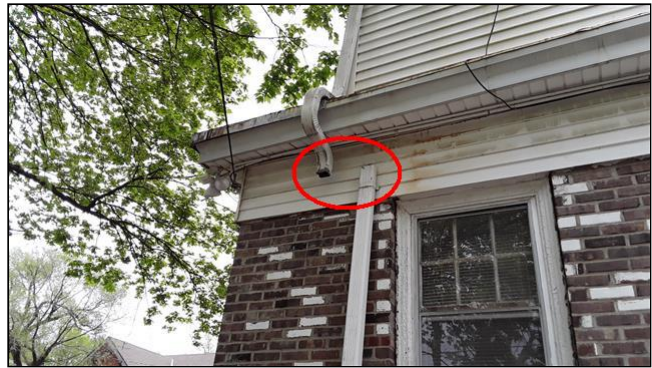
(2) Downspout disconnected at NW corner and North side of home. Recommend reconnecting to facilitate proper drainage away from home and avoid associated moisture damages. None visible during time of inspection.

3.0 Item 2(Picture) - Downspout disconnected at E corner

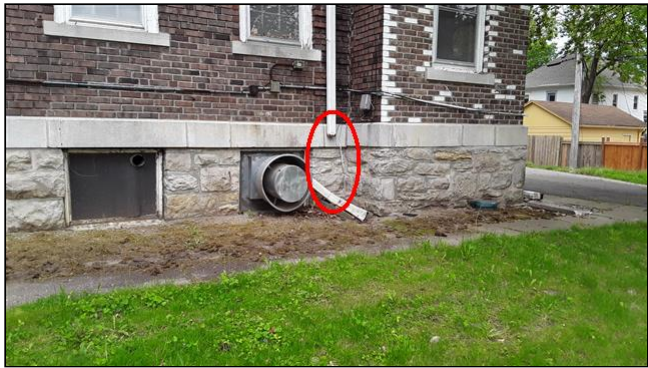
3.0 Item 3(Picture) - Downspout disconnected on West side

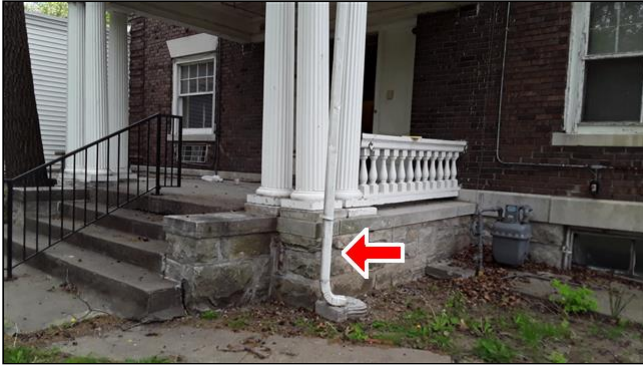
(3) Downspout loose around front porch. Recommend properly securing to maintain reliable water flow away from home and avoid possible moisture penetration and associated damages within basement. None visible during time of inspection.

3.0 Item 4(Picture) - Loose downspout at front porch

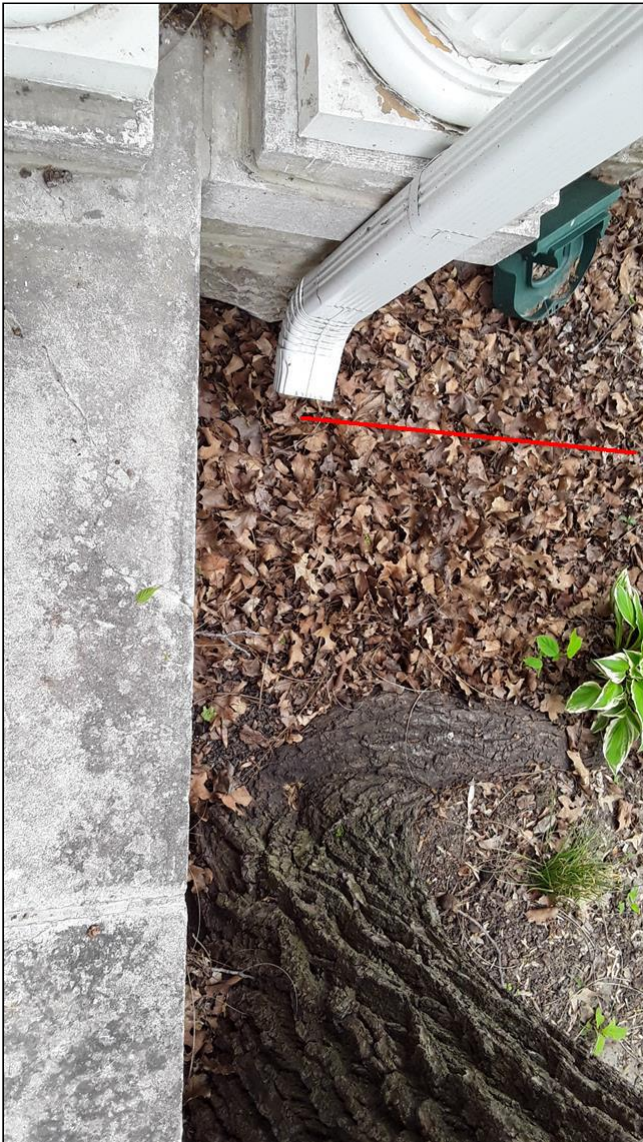
(4) Downspout drains water too close to foundation at front porch. Recommend extending at least 6' away from foundation wall to avoid possibility of moisture penetration and associated damages. None visible during time of inspection.

3.0 Item 5(Picture) - Extend at front porch

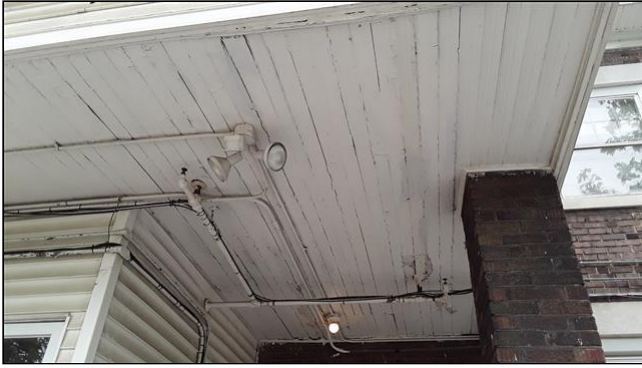
(1) Rot in soffit boards on West side of home. This is normal in older homes. Recommend properly repairing to avoid possible moisture penetration and associated damages to underlying framing areas. None visible during time of inspection.

3.1 Item 1(Picture) - Rot in soffit boards over basement walkout steps

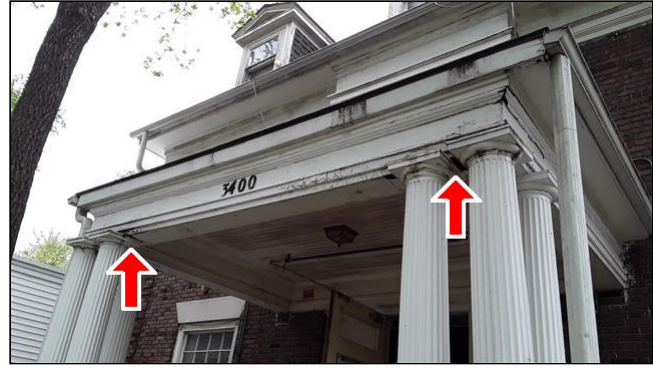
3.1 Item 2(Picture) - Rot at soffits at front porch

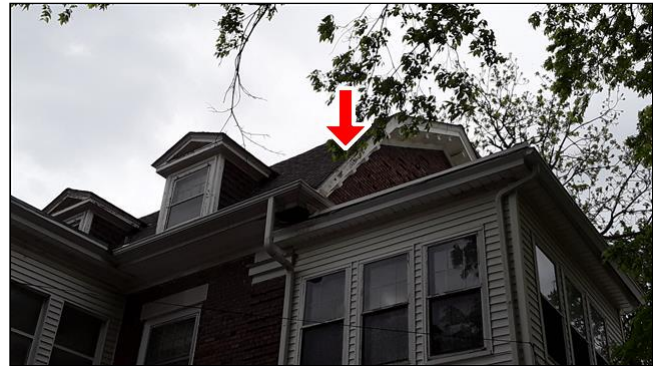
3.1 Item 5(Picture) - Peeling paint on West side

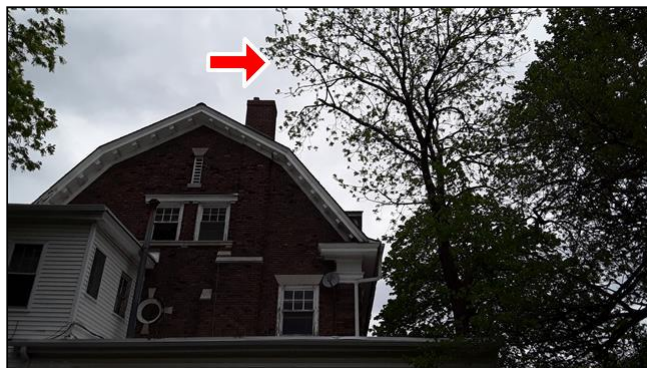
Tree branches overhang onto roof. All tree branches should be kept trimmed back at least 6 to 8 feet from roof and gutters to avoid possible rodent damage and reduce associated debris from clogging gutters. Recommend trimming to avoid associated structural damages. None visible during time of inspection.

3.2 Item 1(Picture) - Tree branches hang over roof

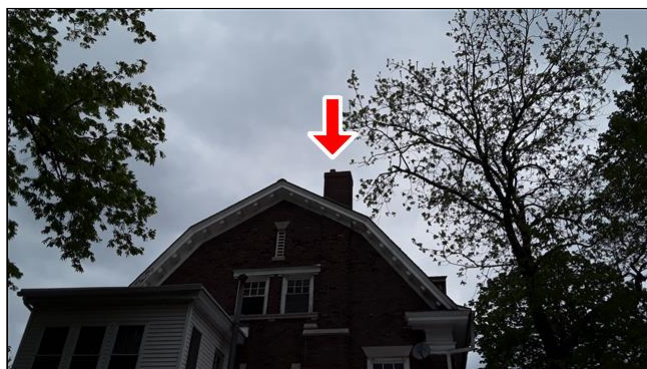
Missing chimney caps. Recommend installing to maintain safe and proper chimney performance. Unable to determine if any underlying damages exist during time of inspection.

3.5 Item 1(Picture) - Missing chimney cap

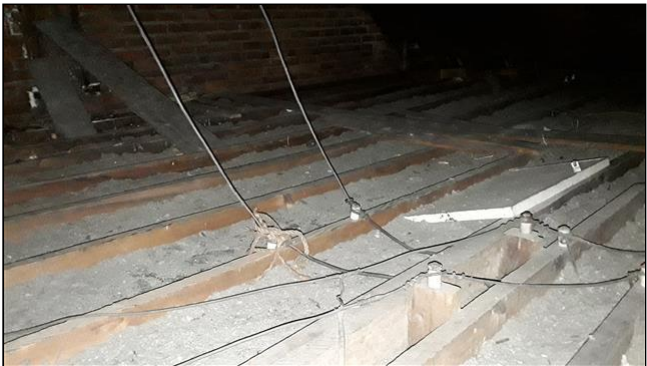
1 inch of blown fiberglass insulation present. U.S. Department of Energy recommends R-38 rating in attic spaces, which equates to 13 inches. Consider providing additional depth to maintain intended energy efficiency to home and reduce associated fuel costs.

4.1 Item 1(Picture) - 1 inch of blown fiberglass insulation in attic

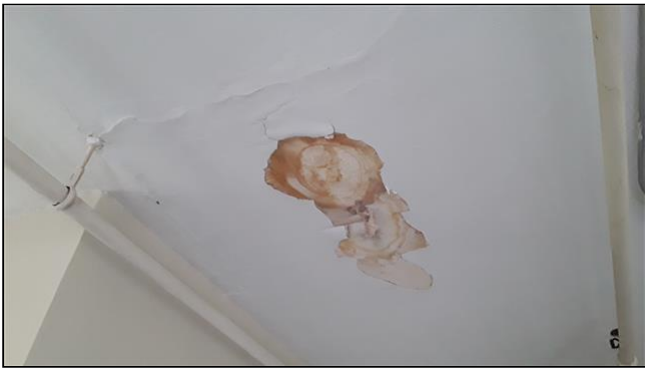
5.2.A Item 1(Picture) - Old moisture stains and damage at NE corner of top floor

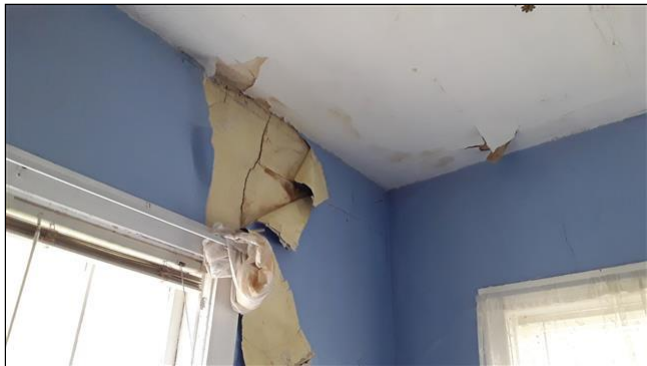
5.2.B Item 1(Picture) - Moisture stains and damage at NW corner of second floor

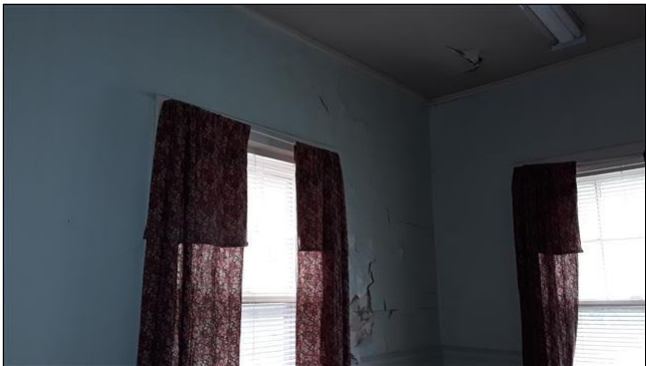
5.2.B Item 2(Picture) - Moisture damage continues onto main floor

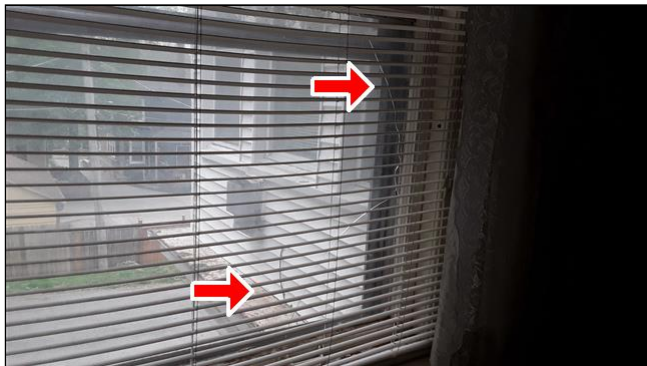
5.3.B Item 1(Picture) - Cracked pane on West side of second floor

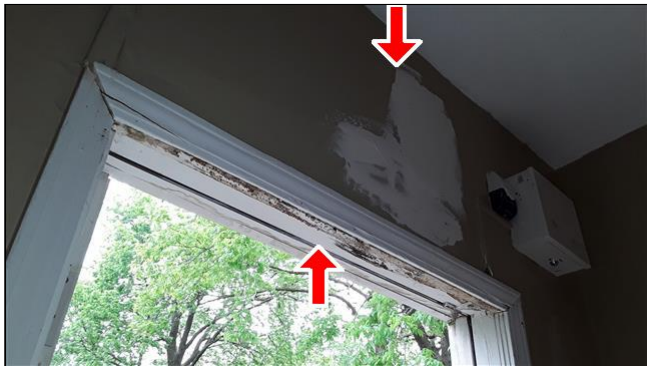
5.1.C Item 1(Picture) - Moisture stains and damages on South side of main floor

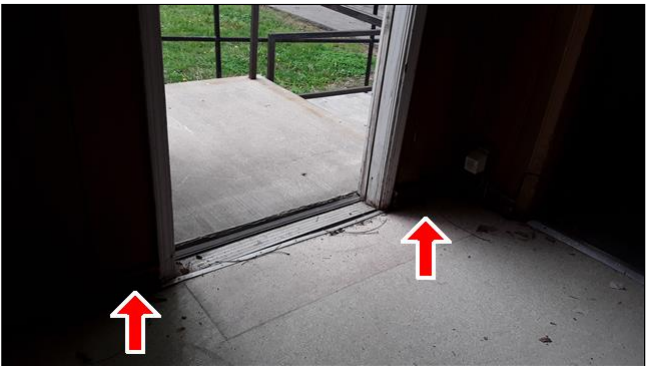
5.1.C Item 2(Picture) - Moisture damages at floor around South walkout door

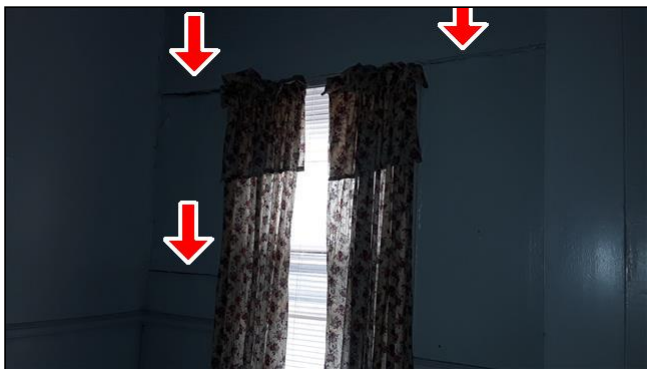
5.1.C Item 3(Picture) - Moisture damages on West side of main floor

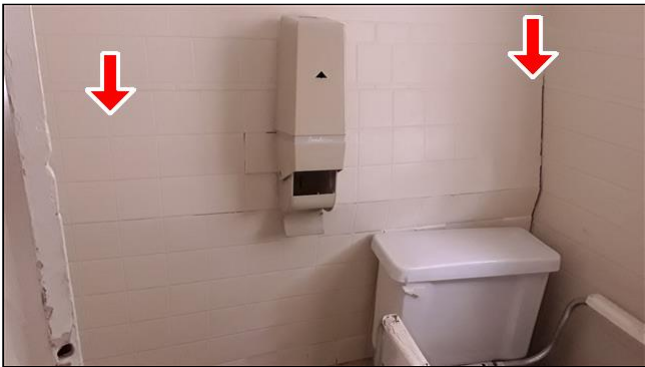
Plaster wall is collapsing in second floor South side bathroom. Recommend hiring professional contractor specialist to investigate and repair to avoid further movement. Unable to determine extent of underlying damages during time of inspection.

6.2.C Item 1(Picture) - Plaster wall is collapsing in second floor South side bathroom

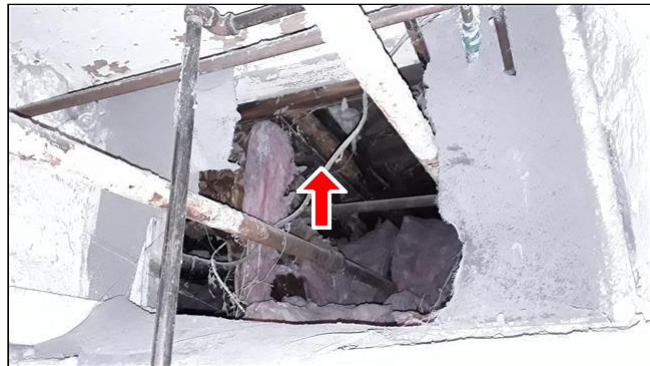
Termite damage at floor joist within crawlspace. No previous treatment is visible and none is disclosed. Recommend hiring professional pest control company to thoroughly treat to avoid future activity and associated damages. No live termites and no significant structural damages visible during time of inspection.

9.4 Item 1(Picture) - Termite damage at floor joist in crawlspace

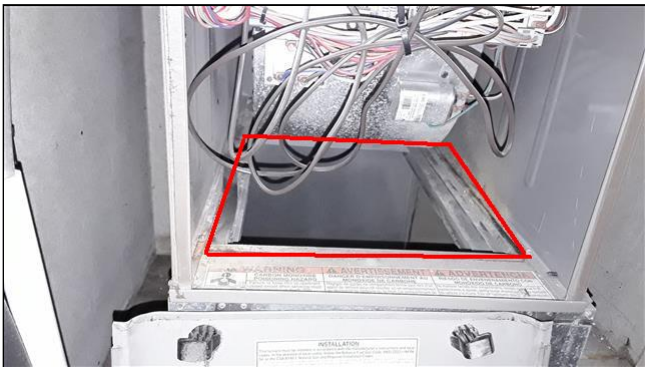
11.1 Item 1(Picture) - Missing filter in main floor furnace

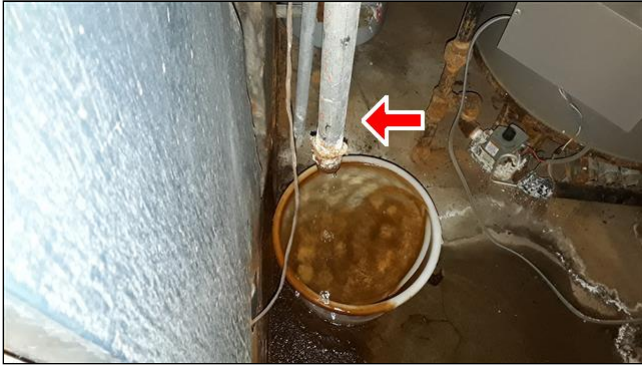
(2) Active leakage at boiler drip tube. This can be caused by high tank pressure or sediment beneath valve seat. Recommend contracting professional plumber to evaluate and repair to restore proper performance.

11.1 Item 2(Picture) - Boiler drip tube is leaking

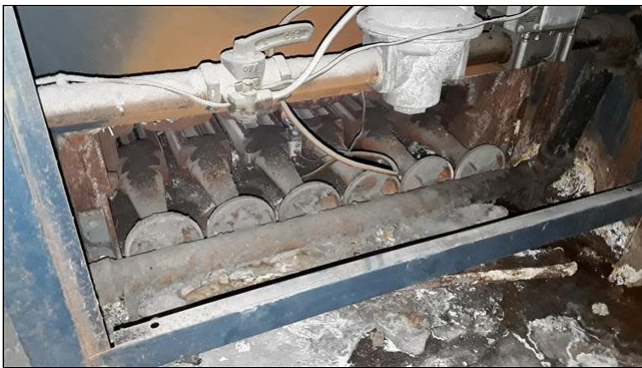
(3) Boiler displays heavy rust and corrosion in and around unit. Unable to determine extent of underlying damages, but unit performs as intended during time of inspection. Recommend having unit serviced prior to closing to maximize life and system efficiency. Budget for future replacement.

11.1 Item 3(Picture) - Rust and corrosion inside boiler burner area

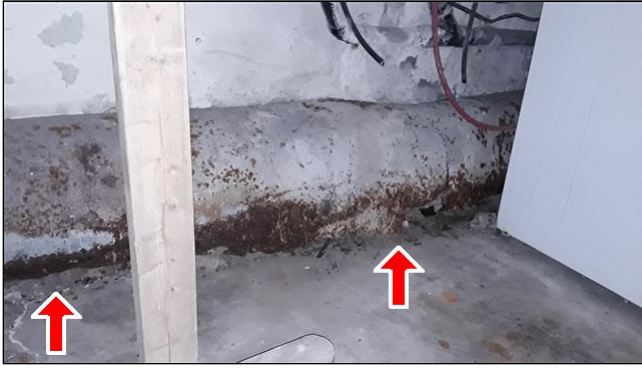
11.8 Item 1(Picture) - Make-up vent is corroded in laundry area

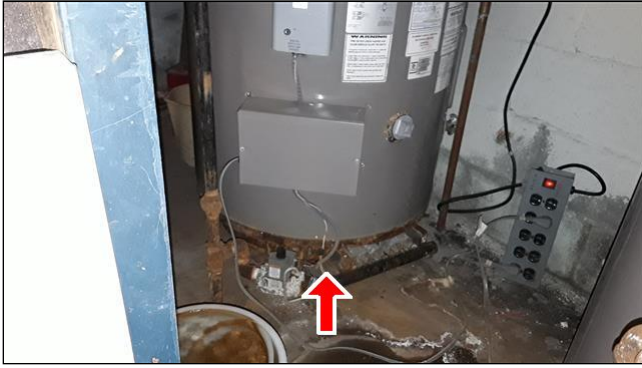
12.5 Item 1(Picture) - Corrosion on bottom of water heater

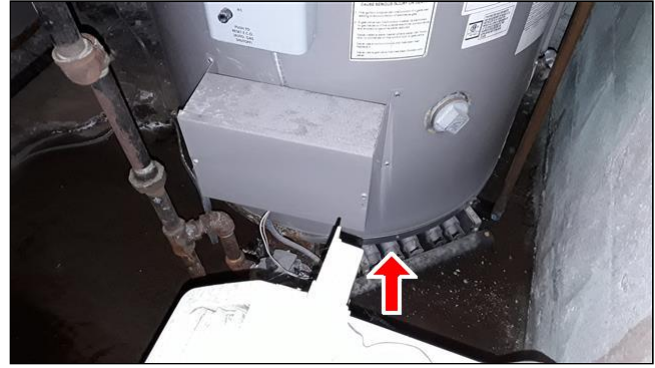
12.5 Item 2(Picture) - Corrosion on bottom of second water heater
