Subject: Mold Assessment
1600 Jackson Avenue
Kansas City, Missouri 64127

New Horizons Enterprises, LLC (New Horizons) performed mold assessment at the above-mentioned address. The purpose of this investigation is to determine the presence of mold within the common areas and limited number of apartment units due to historical complaints. The assessment took place on November 19, 2020.

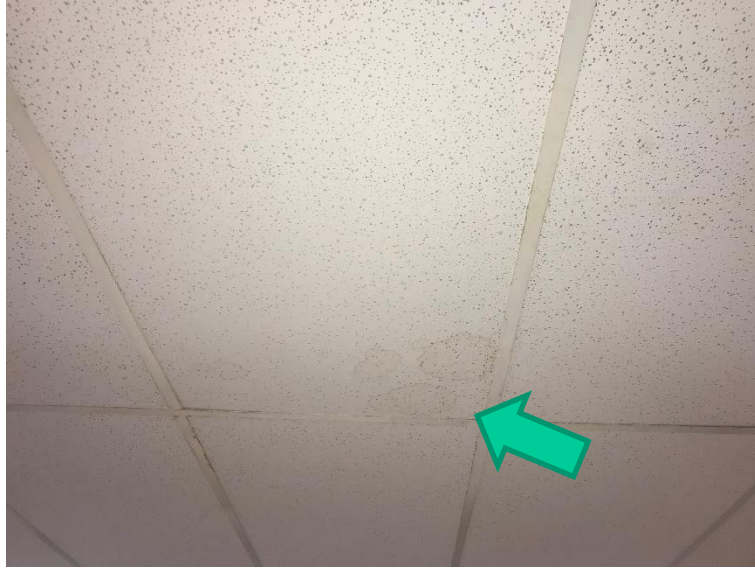
DIRECTION: Interior	DESCRIPTION	This photograph shows water staining on a ceiling tile in first floor community room.	1
	CLIENT	Economic Development Corporation of Kansas City	DATE
	PHOTOGRAPHER	Jake Nelson	11/19/2020

Based on this sampling, New Horizons has identified an issue with mold in the limited areas assessed. New Horizons recommends fixing any leaks or water intrusion sources to prevent further mold growth. New Horizons recommends removal and replacement of any affected building materials, including drywall, ceiling tile, and any other moisture-impacted building materials. New Horizons also recommends treating all remaining hard surfaces with a mold inhibitor to eliminate mold in the work area. New Horizons recommends this be completed by a mold remediation contractor to ensure the proper work methods are conducted to limit release of spores into the air. After mold remediation is completed, New Horizons recommends conducting follow up air testing to ensure the air quality in the building was not impacted by remediation activities.

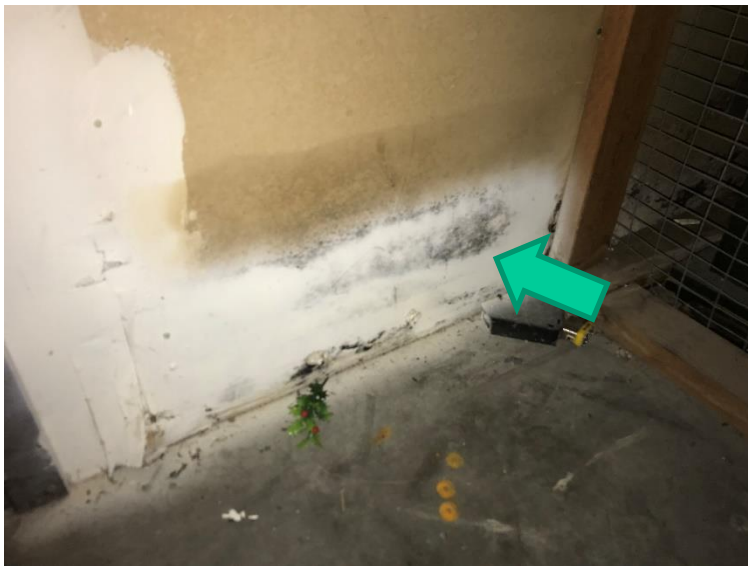
New Horizons collected indoor air sample AS-2 in the first-floor tenant storage. The results indicate higher levels of total mold spores compared to the background sample. All molds were identified in this sample at a lower level than in the background sample, with the exception of Ascospores, *Aspergillus/Penicillium Group*, Basidiospores, *Chaetomium*, *Curvularia*, *Epicoccum*, *Pithomyces/Ulocladium*, Pollen, and *Stachybotrys*. These molds were identified at low levels. *Aspergillus/Penicillium Group* was identified at a slightly elevated level and not identified in the background sample. *Pithomyces/Ulocladium* and *Stachybotrys* were identified at low levels and were not identified in the background sample. See AS-1 for the description of *Aspergillus/Penicillium Group*.

DIRECTION: Interior	DESCRIPTION	This photograph shows mold on a drywall wall in the tenant storage room on the first floor.	2
	CLIENT	Economic Development Corporation of Kansas City	DATE
	PHOTOGRAPHER	Jake Nelson	11/19/2020

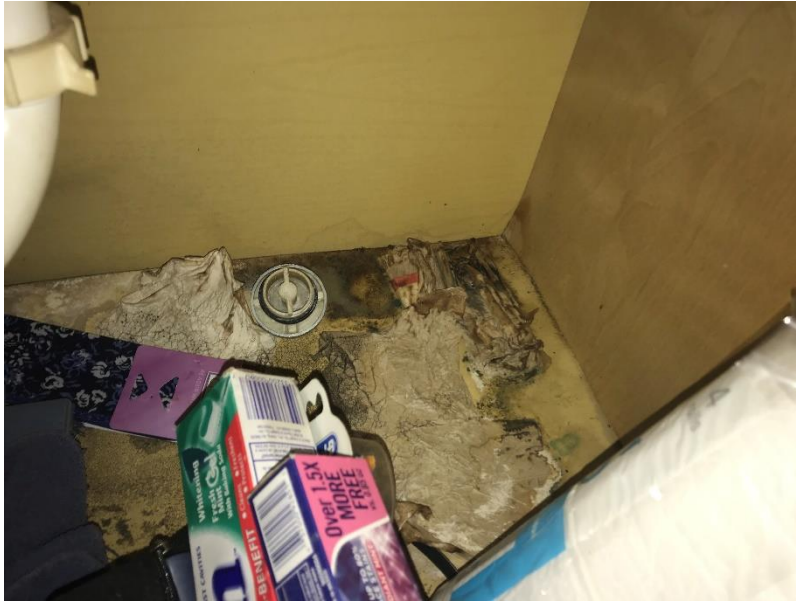
On November 19, 2020, New Horizons performed a visual assessment of the common areas and select apartments. Visible mold was identified on tenant storage room walls, and walls and heating, ventilation, and air conditioning (HVAC) units of apartment Units 505, 406, and 305. Water-damaged ceiling tiles were observed in common rooms. In addition, water damaged wood was observed under sinks in apartment Units 901 and 815.

DIRECTION: Interior	DESCRIPTION	This photograph shows water damage on the wood cabinet under the sink in unit 901.	3
	CLIENT	Economic Development Corporation of Kansas City	DATE
	PHOTOGRAPHER	Jake Nelson	11/19/2020

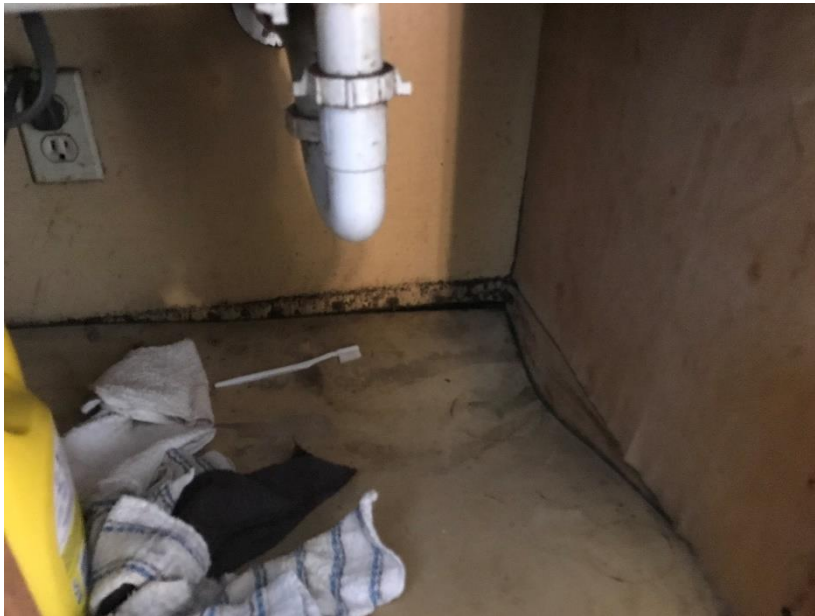
DIRECTION: Interior	DESCRIPTION	This photograph shows water damage on the wood cabinet under the sink in unit 815.	4
	CLIENT	Economic Development Corporation of Kansas City	DATE
	PHOTOGRAPHER	Jake Nelson	11/19/2020

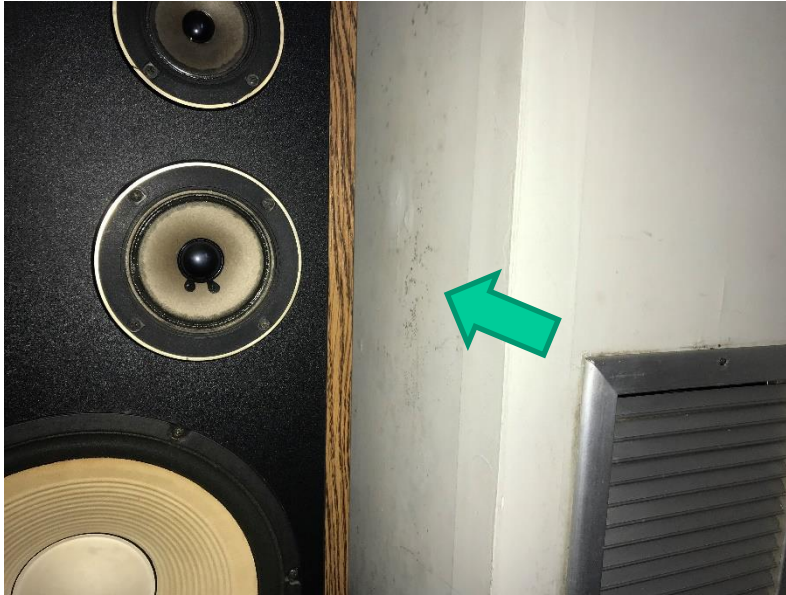
New Horizons collected indoor air sample AS-8 in the living area of Unit 505. The cassette was overloaded and specific counts could not be determined. All molds identified in this sample were identified in the background sample, except *Pithomyces/Ulocladium*, *Aspergillus/Penicillium Group*, and *Tetraploa*. *Pithomyces/Ulocladium* and *Aspergillus/Penicillium Group* are described above in AS-1.

DIRECTION: Interior	DESCRIPTION	This photograph shows mold on a drywall wall in unit 505.	5
	CLIENT	Economic Development Corporation of Kansas City	DATE 11/19/2020
	PHOTOGRAPHER	Jake Nelson

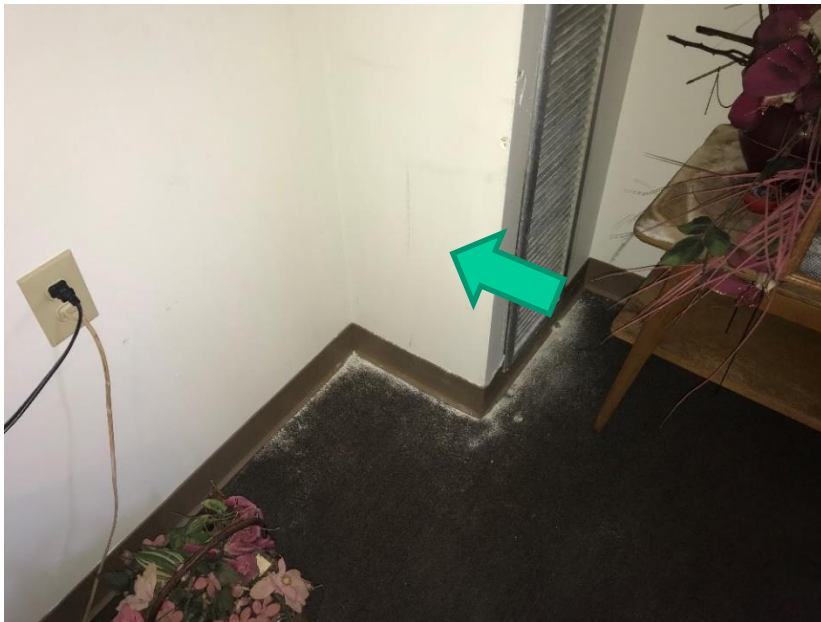
New Horizons collected indoor air sample AS-9 in the living area of Unit 406. The results indicate lower levels of total mold spores compared to the background sample. All molds identified were at lower levels than those in the background sample except for *Chaetomium* and *Curvularia*. *Aspergillus/Penicillium Group* and *Stachybotrys* were identified at low levels in this sample and were not identified in the background sample. See AS-1 for description of *Aspergillus/Penicillium Group* and AS-2 for descriptions of *Chaetomium*, *Curvularia*, and *Stachybotrys*.

DIRECTION: Interior	DESCRIPTION	This photograph shows a wall, which was made known to New Horizons, that had visible mold and was cleaned by the tenant in unit 406.	6
	CLIENT	Economic Development Corporation of Kansas City	DATE 11/19/2020
	PHOTOGRAPHER	Jake Nelson

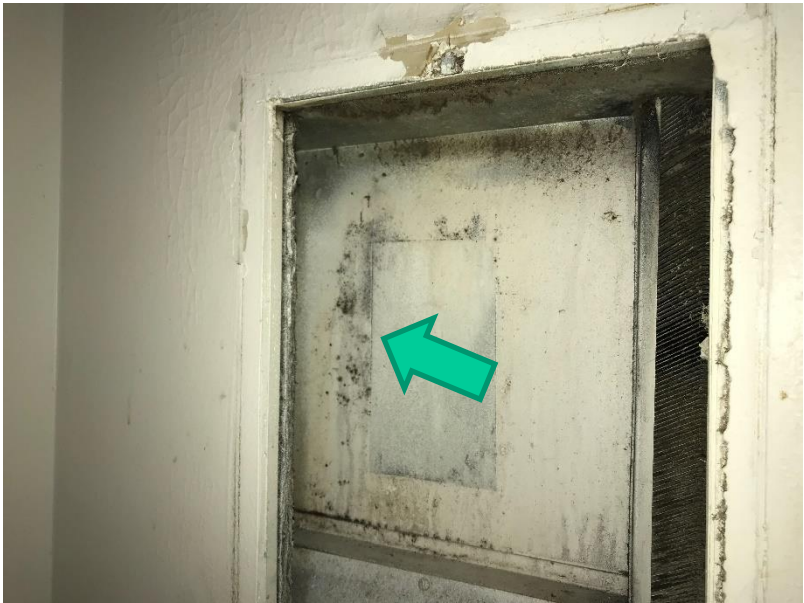
New Horizons collected indoor air sample AS-10 in the living area of Unit 305. The results indicate higher levels of total mold spores compared to the background sample. All molds identified were at lower levels than those in the background sample except for *Basidiospores*, Hyphal Fragments, *Periconia/Myxomycetes/Smuts*, Pollen, and Rusts. *Aspergillus/Penicillium Group* and *Bipolaris/Drechslera Group (2)* were identified at low levels in this sample and were not identified in the background sample. See AS-1 for description of *Aspergillus/Penicillium Group*, AS-2 for descriptions of *Basidiospores* and Pollen, and AS-7 for description of *Bipolaris/Drechslera Group (2)*.

DIRECTION: Interior	DESCRIPTION	This photograph shows mold on the HVAC system of unit 305.	7
	CLIENT	Economic Development Corporation of Kansas City	DATE
	PHOTOGRAPHER	Jake Nelson	11/19/2020
