Re: 3400-3408 Campbell Street URA

## PROPERTY CONDITION REPORT

CLIENT:	Jesse Peoples
INSPECTION ADDRESS:	3400 Campbell St. Kansas City MO 64109
AGENT:	None
DATE:	4/25/2017
INSPECTOR:	Steve Rodriguez
REPORT #:	20170425-3400-Campbell-St

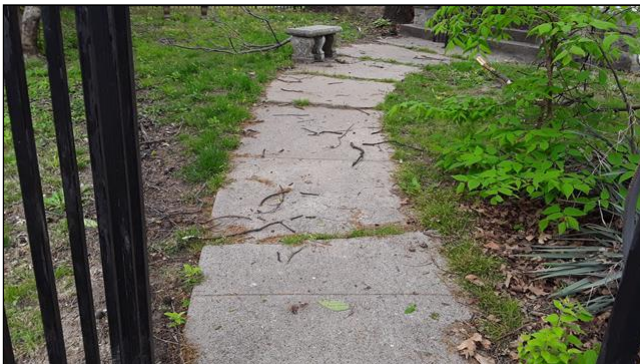
Walkway has moved and cracked to a point where it has created a tripping hazard on East side. Recommend properly repairing to avoid associated personal injuries.

1.2 Item 1(Picture) - Settlement cracking at front walkway

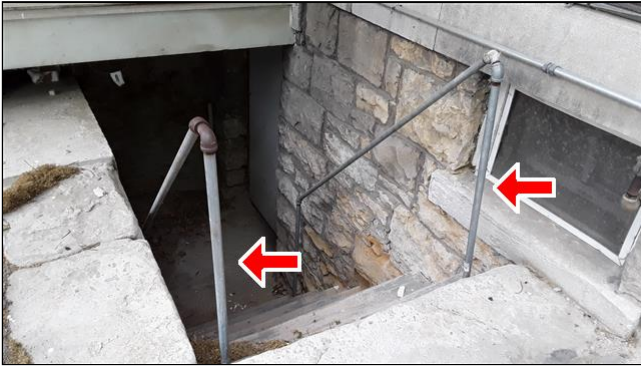
Handrails are loose at basement walkout steps. Recommend properly securing to maintain proper stability during use.

2.7 Item 1(Picture) - Loose handrails at basement walkout steps

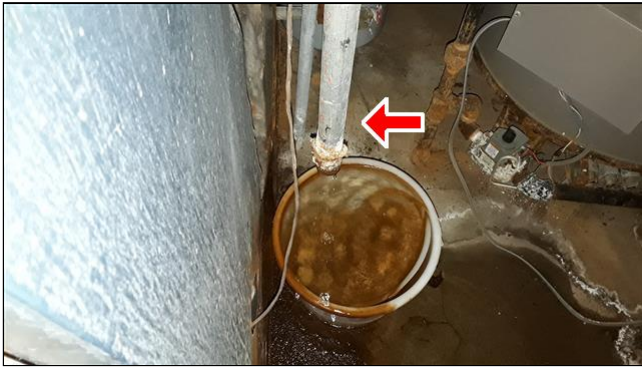
(2) Active leakage at boiler drip tube. This can be caused by high tank pressure or sediment beneath valve seat. Recommend contracting professional plumber to evaluate and repair to restore proper performance.

11.1 Item 2(Picture) - Boiler drip tube is leaking

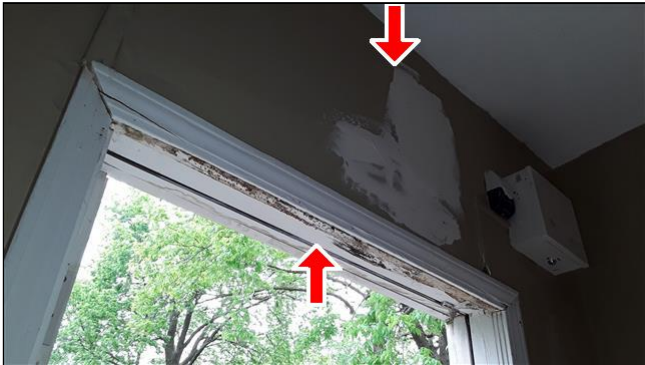
**Specialist Item.**  
Moisture damages visible on South and West walls of home, but no moisture detected during time of inspection. This appears to be caused from previous leakage at roof above stain. Recommend hiring professional roofing contractor to investigate and repair to avoid continued future damages. Unable to determine extent of underlying damages during time of inspection.

5.1.C Item 1(Picture) - Moisture stains and damages on South side of main floor

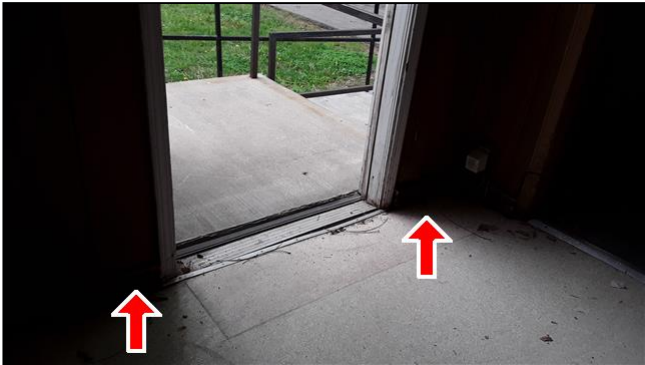
5.1.C Item 2(Picture) - Moisture damages at floor around South walkout door

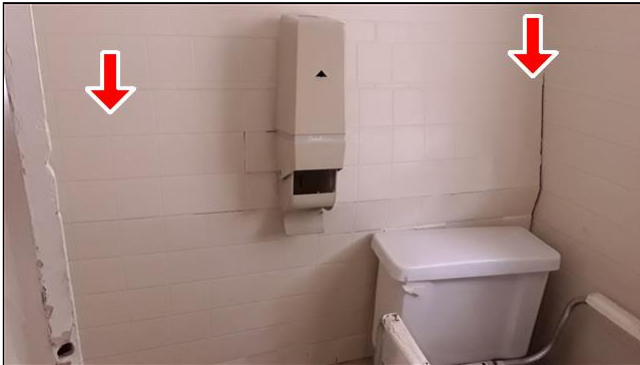
Plaster wall is collapsing in second floor South side bathroom. Recommend hiring professional contractor specialist to investigate and repair to avoid further movement. Unable to determine extent of underlying damages during time of inspection.

6.2.C Item 1(Picture) - Plaster wall is collapsing in second floor South side bathroom

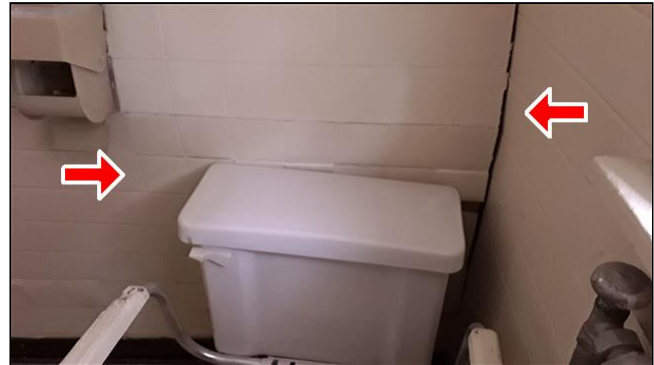
6.2.C Item 2(Picture) - Another angle of collapsing wall in second floor South bathroom

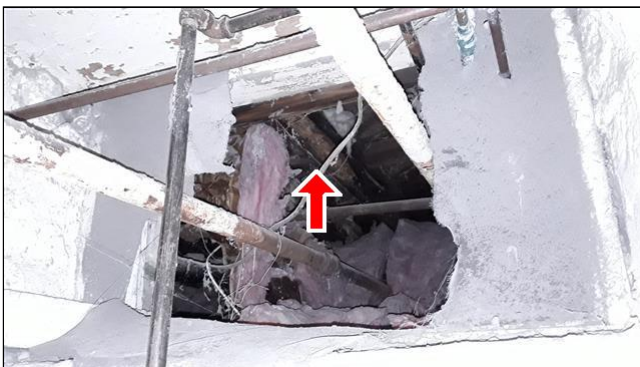
Termite damage at floor joist within crawlspace. No previous treatment is visible and none is disclosed. Recommend hiring professional pest control company to thoroughly treat to avoid future activity and associated damages. No live termites and no significant structural damages visible during time of inspection.

9.4 Item 1(Picture) - Termite damage at floor joist in crawlspace

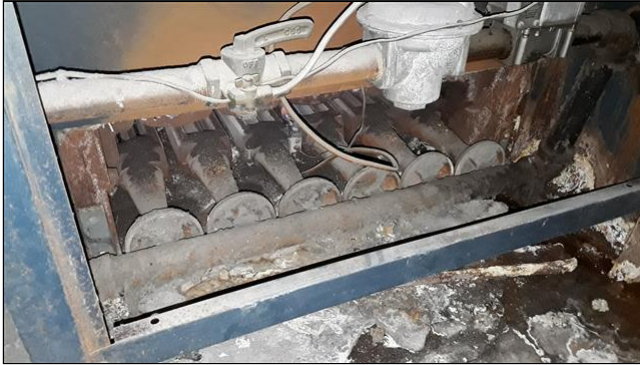
(3) Boiler displays heavy rust and corrosion in and around unit. Unable to determine extent of underlying damages, but unit performs as intended during time of inspection. Recommend having unit serviced prior to closing to maximize life and system efficiency. Budget for future replacement.

11.1 Item 3(Picture) - Rust and corrosion inside boiler burner area

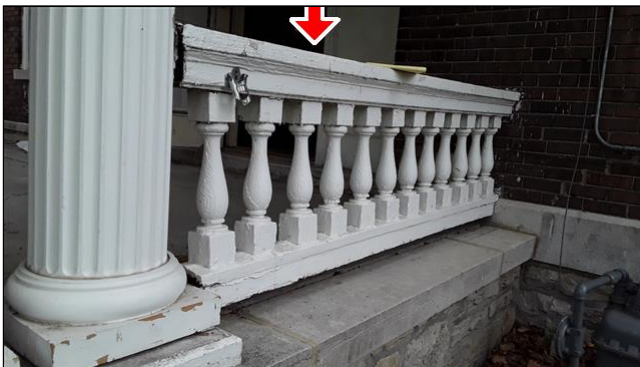
(2) Loose banister at front porch. Recommend properly securing to maintain proper stability during use.

1.3 Item 2(Picture) - Loose banister at front porch

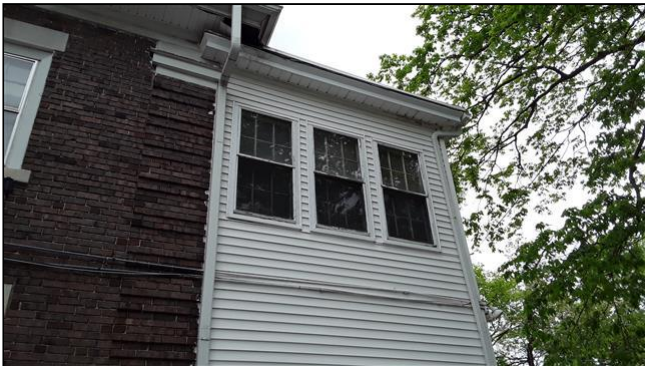
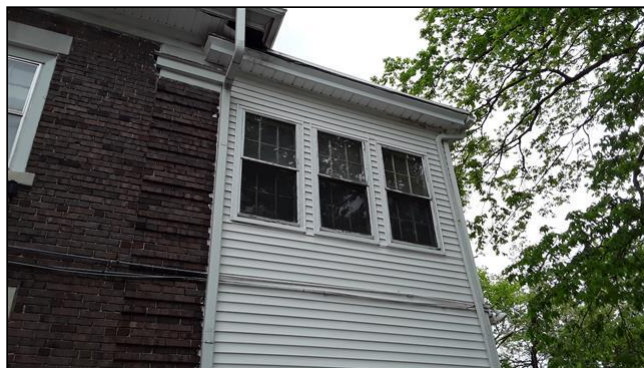
Peeling paint and rot at window frames and sills around home. Recommend properly repairing and repainting to avoid continued damage to underlying framing areas. No significant underlying damages visible during time of inspection.

2.3 Item 2(Picture) - Peeling paint at NW windows

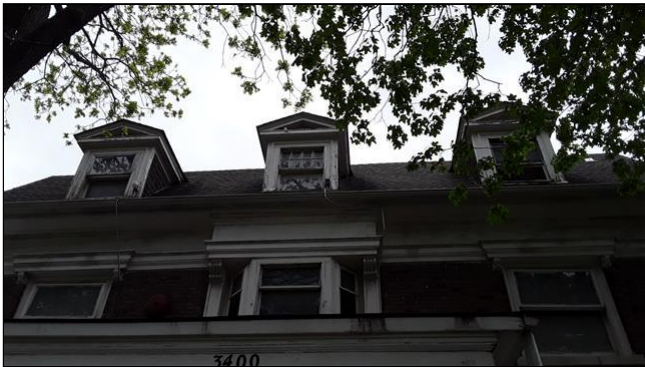
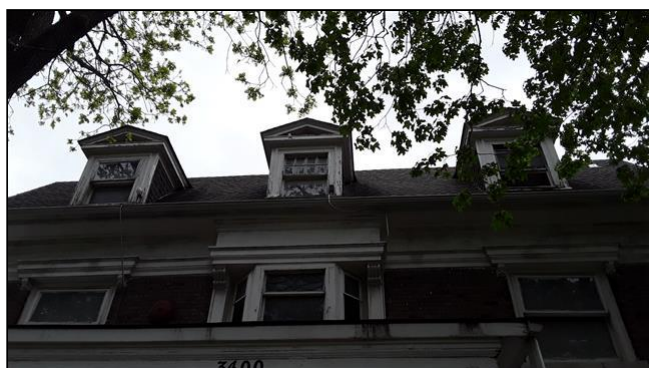
2.3 Item 5(Picture) - Peeling paint on East side

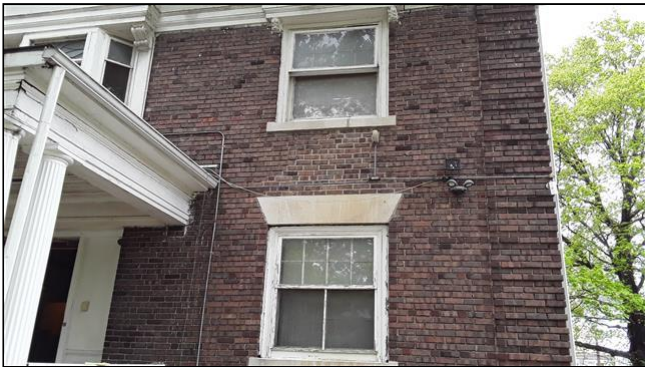
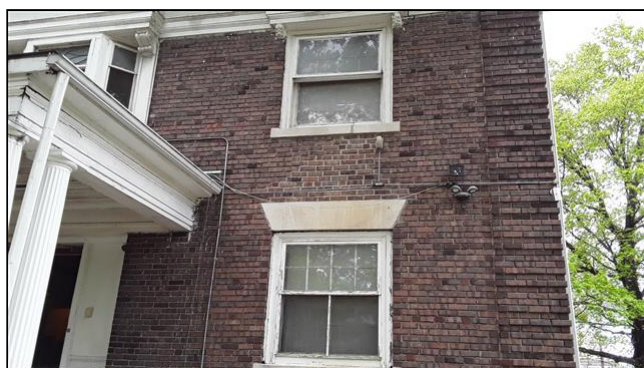
2.3 Item 6(Picture) - Peeling paint at NE corner

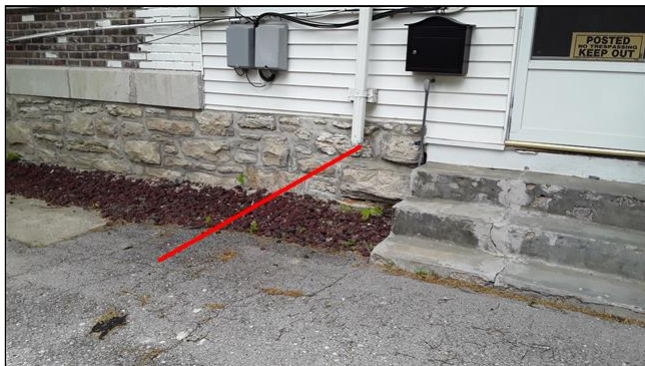
(1) Downspout missing elbow on West side of home. Recommend installing and extending at least 6' to facilitate proper drainage away from foundation and avoid associated moisture damages. None visible during time of inspection.

3.0 Item 1(Picture) - Missing elbow on West side

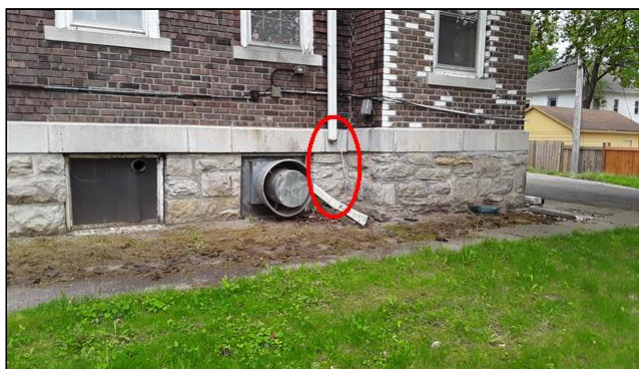
(2) Downspout disconnected at NW corner and North side of home. Recommend reconnecting to facilitate proper drainage away from home and avoid associated moisture damages. None visible during time of inspection.

3.0 Item 3(Picture) - Downspout disconnected on West side

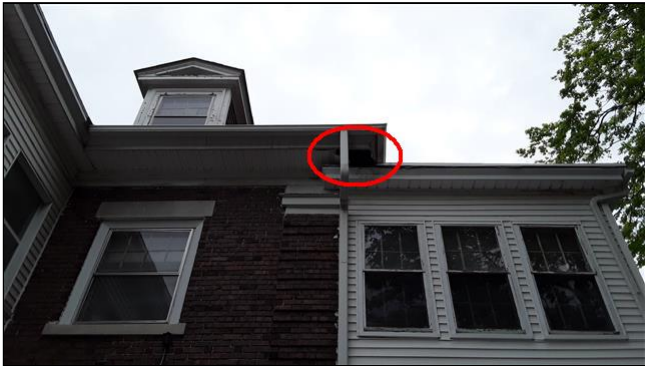
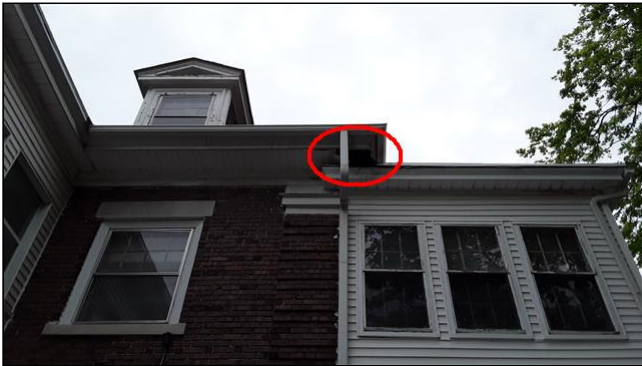
(2) Damaged soffit board on West side of home. Recommend properly repairing to avoid possible moisture penetration and associated damages to underlying framing areas. No significant damages visible during time of inspection.

3.1 Item 3(Picture) - Damaged soffit on West side of home

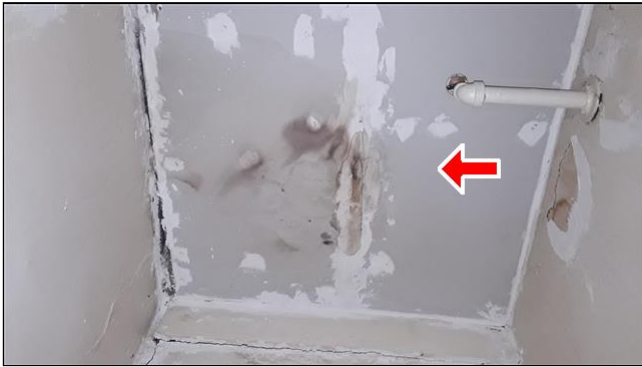
Old moisture stains and damage visible in closet on West side of second floor, but no moisture detected during time of inspection. This appears to be caused from previous leakage at roof above stain. Recommend properly sealing and painting to avoid future moisture damage. No underlying moisture damages visible during time of inspection.

5.5.B Item 1(Picture) - Old moisture stains in West side closet

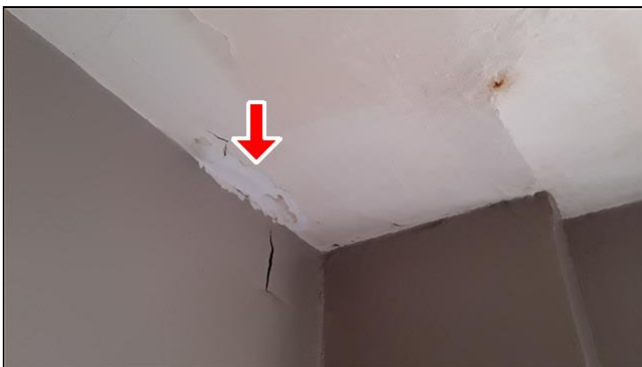
Old moisture stains and damage visible at ceiling, but no moisture detected during time of inspection. This appears to be caused from previous leakage at roof above stain. Recommend properly sealing and painting to avoid future moisture damage. No underlying moisture damages visible during time of inspection.

6.3.A Item 1(Picture) - Old moisture stains and damages in top floor bathroom ceiling

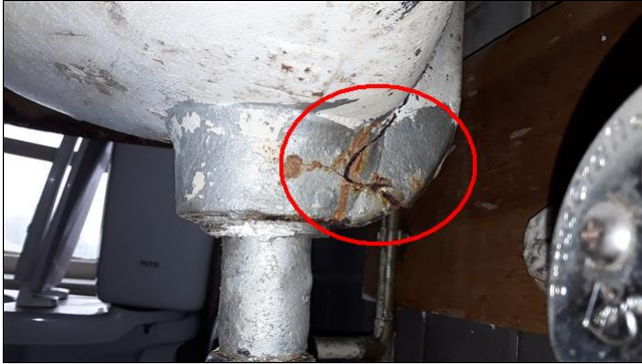
Cast iron sink is cracked and leaking. Recommend properly repairing to avoid further leakage and associated moisture damages. No moisture damages visible during time of inspection.

6.9.A Item 1(Picture) - Cracked sink in top floor bath

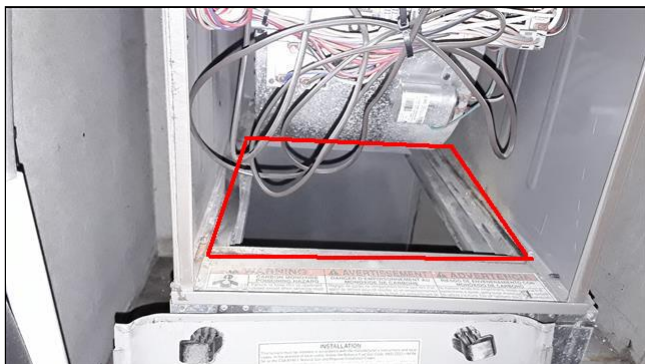
(1) Furnace filter is missing. If left unattended, this will reduce efficiency and life of furnace. Recommend installing to maintain proper performance.

11.1 Item 1(Picture) - Missing filter in main floor furnace

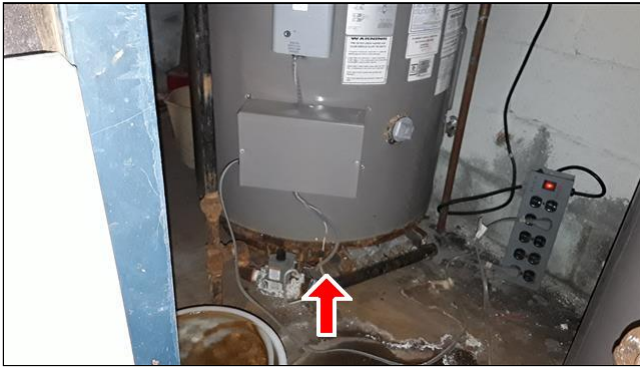
Rust and corrosion in and around both water heaters. Units are 10 years old and operate as intended during time of inspection. These conditions and their age (typical life of water heater is 10-12 years) indicate units are at the end of their useful life. Budget for future replacement.

12.5 Item 1(Picture) - Corrosion on bottom of water heater

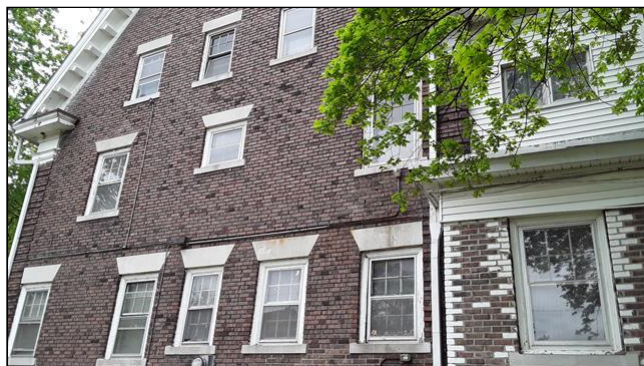
2.3 Item 4(Picture) - Peeling paint on North side

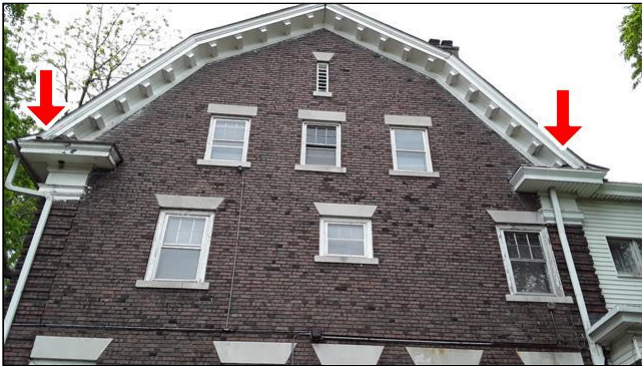
(3) Peeling paint and rot at rake/fascia boards around home. Recommend properly repairing and repainting all damaged areas to extend their useful life. No significant underlying damages visible during time of inspection.

3.1 Item 4(Picture) - Rot at rake boards on North side of home

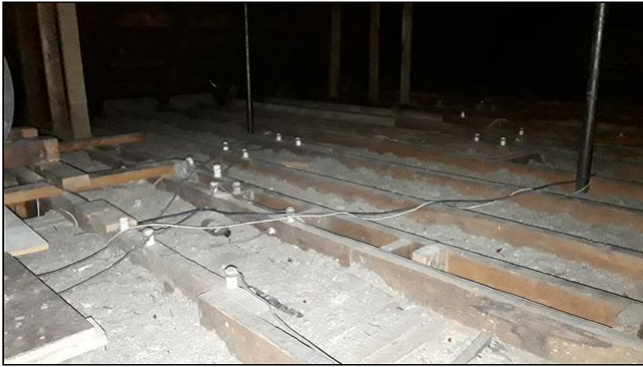
(2) Knob-and-tube wiring system installed within home. This is original to the home and unsafe since today's attics are insulated. Recommend contracting electrician to thoroughly evaluate and replace all areas to maintain safe and reliable electrical service throughout home. No underlying electrical damages visible during time of inspection.

4.5 Item 1(Picture) - Knob-n-tube wiring in attic

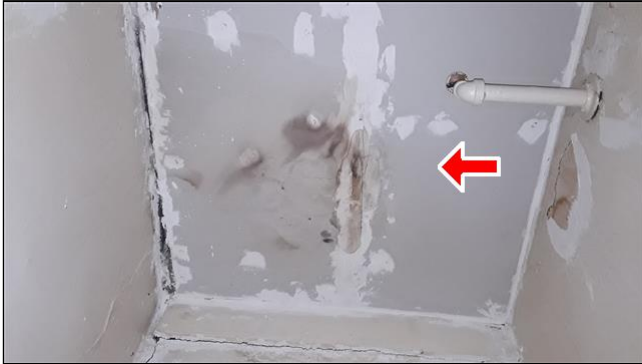
Old moisture stains and damage visible in closet on West side of second floor, but no moisture detected during time of inspection. This appears to be caused from previous leakage at roof above stain. Recommend properly sealing and painting to avoid future moisture damage. No underlying moisture damages visible during time of inspection.

5.5.B Item 1(Picture) - Old moisture stains in West side closet

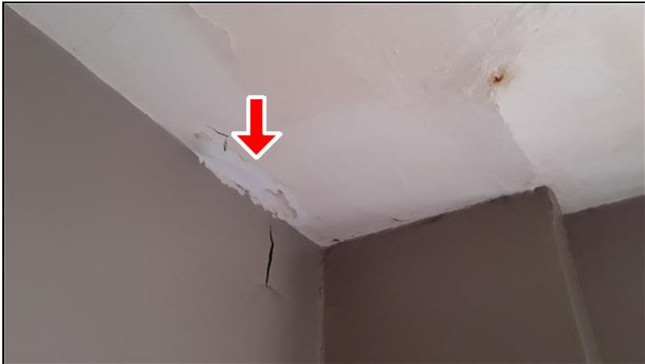
Old moisture stains and damage visible at ceiling, but no moisture detected during time of inspection. This appears to be caused from previous leakage at roof above stain. Recommend properly sealing and painting to avoid future moisture damage. No underlying moisture damages visible during time of inspection.

6.3.A Item 1(Picture) - Old moisture stains and damages in top floor bathroom ceiling
- 6.4.A WINDOW

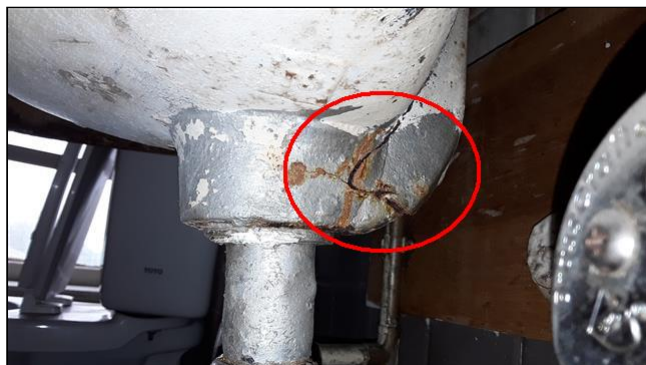
Cast iron sink is cracked and leaking. Recommend properly repairing to avoid further leakage and associated moisture damages. No moisture damages visible during time of inspection.

6.9.A Item 1(Picture) - Cracked sink in top floor bath

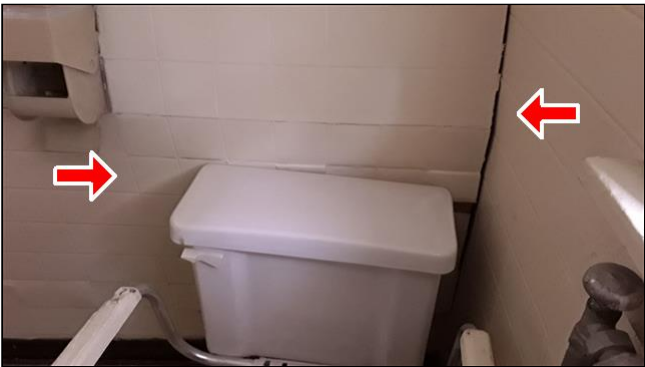
6.2.C Item 2(Picture) - Another angle of collapsing wall in second floor South bathroom

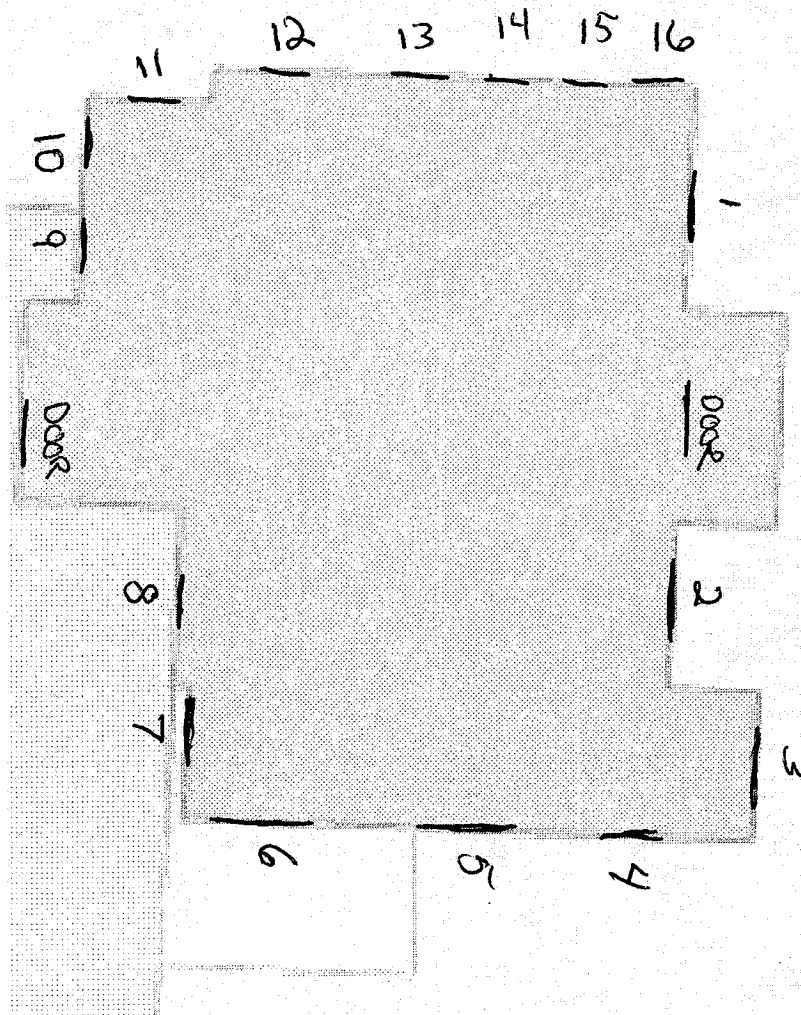
First Floor

1. Can be restored
2. Can be restored
3. Thin aluminum single pane window – should be replaced with thermal window to match original structure.
4. Thin aluminum single pane window – should be replaced with thermal window to match original structure.
5. Thin aluminum single pane window – should be replaced with thermal window to match original structure.
6. Thin aluminum single pane window – should be replaced with thermal window to match original structure.
7. Newer vinyl replacement window – does not need to be replaced
8. Can be restored
9. Replacement window with significant damage – should be replaced
10. Can be restored
11. Can be restored
12. Can be restored
13. Can be restored
14. Can be restored
15. Can be restored
16. Can be restored

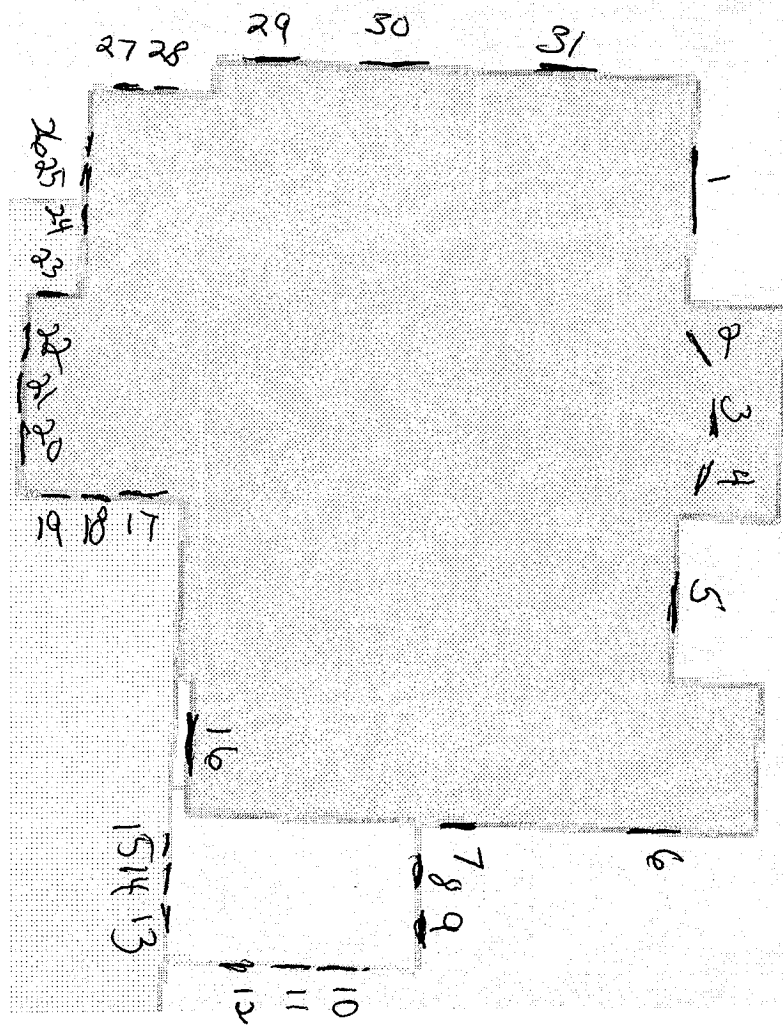
Second Floor

1. Can be restored
2. Can be restored
3. Significant wood rot and missing frame materials – should be replaced
4. Can be restored
5. Can be restored
6. Can be restored

7. Significant wood rot to frames and missing frames – must be replaced
8. Significant wood rot to frames and missing frames – must be replaced
9. Significant wood rot to frames and missing frames – must be replaced

10. Significant wood rot to frames and missing frames – must be replaced
11. Significant wood rot to frames and missing frames – must be replaced
12. Significant wood rot to frames and missing frames – must be replaced

13. Significant wood rot to frames and missing frames – must be replaced
14. Significant wood rot to frames and missing frames – must be replaced
15. Significant wood rot to frames and missing frames – must be replaced

16. Significant wood rot to frames and missing frames – must be replaced
17. Not original windows, inexpensive deteriorated vinyl windows – should be replaced

18. Significant wood rot to frames and missing frames – must be replaced
19. Significant wood rot to frames and missing frames – must be replaced
20. Significant wood rot to frames and missing frames – must be replaced

21. Significant wood rot to frames and missing frames – must be replaced
22. Significant wood rot to frames and missing frames – must be replaced
23. Significant wood rot to frames and missing frames – must be replaced
24. Frame damaged beyond repair – must be replaced
25. Frame damaged beyond repair – must be replaced
26. Frame damaged beyond repair – must be replaced
27. Can be restored
28. Can be restored
29. Frame damaged beyond repair – must be replaced
30. Can be restored
31. Can be restored

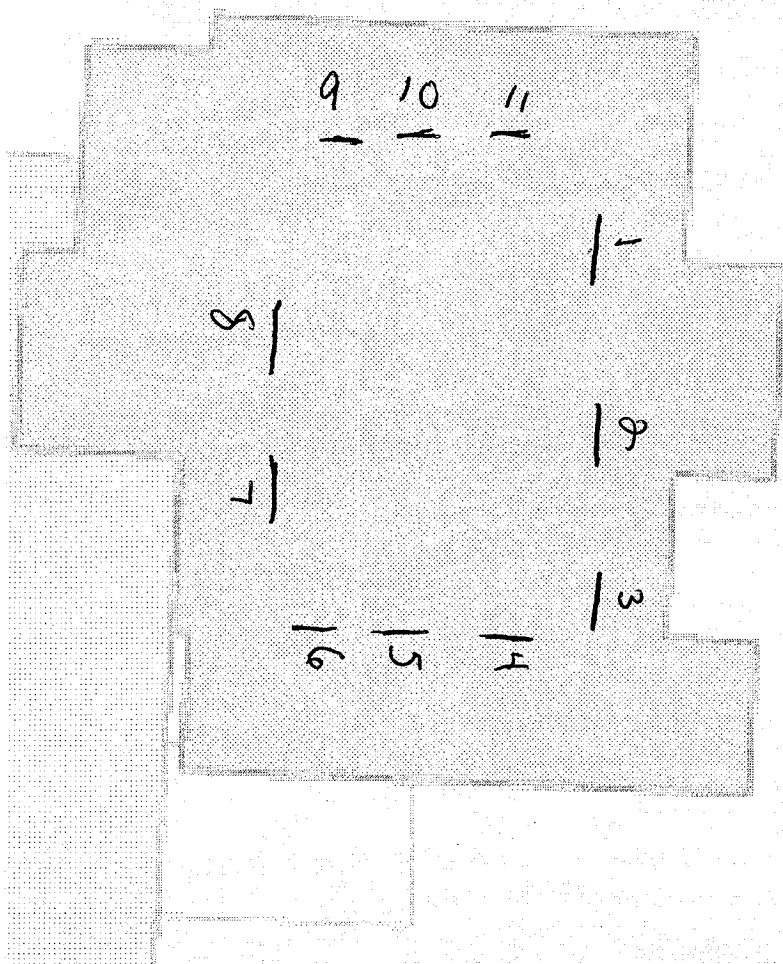
Third Floor

1. Frame damaged beyond repair – must be replaced
2. Frame damaged beyond repair – must be replaced
3. Frame damaged beyond repair – must be replaced
4. Lower sash damaged beyond repair – must be replaced
5. Frame damaged beyond repair – must be replaced
6. Lower sash damaged beyond repair – must be replaced
